**HISTORIC PRESERVATION
ZEPHYRHILLS, FLORIDA**

**Thursday, October 30, 2025
6:00 PM**

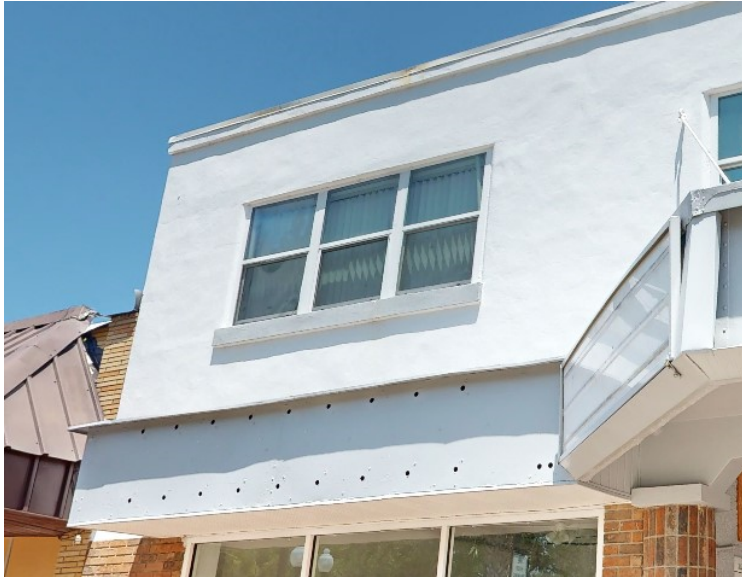
Image 15: Smooth second floor stucco finish.

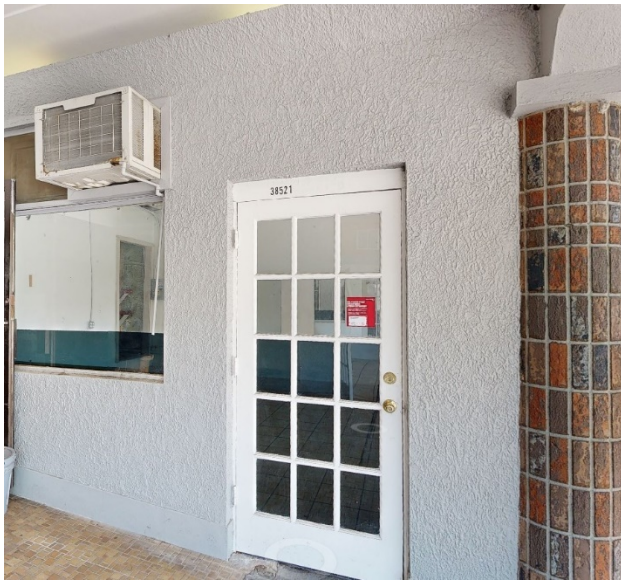
Image 17: Artistically textured stucco.

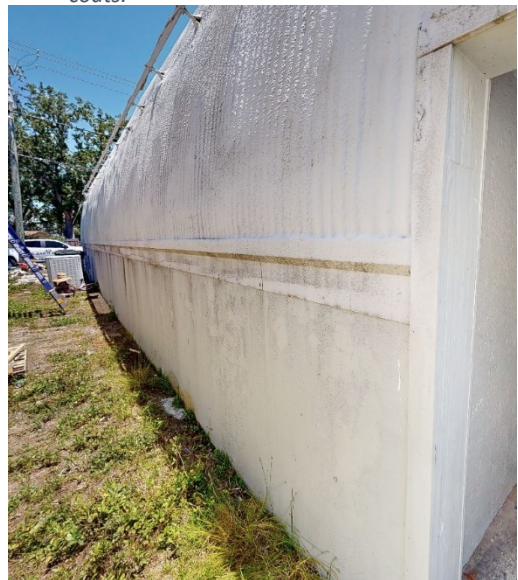
Image 18: Failing stucco and CMU Quonset Hut.

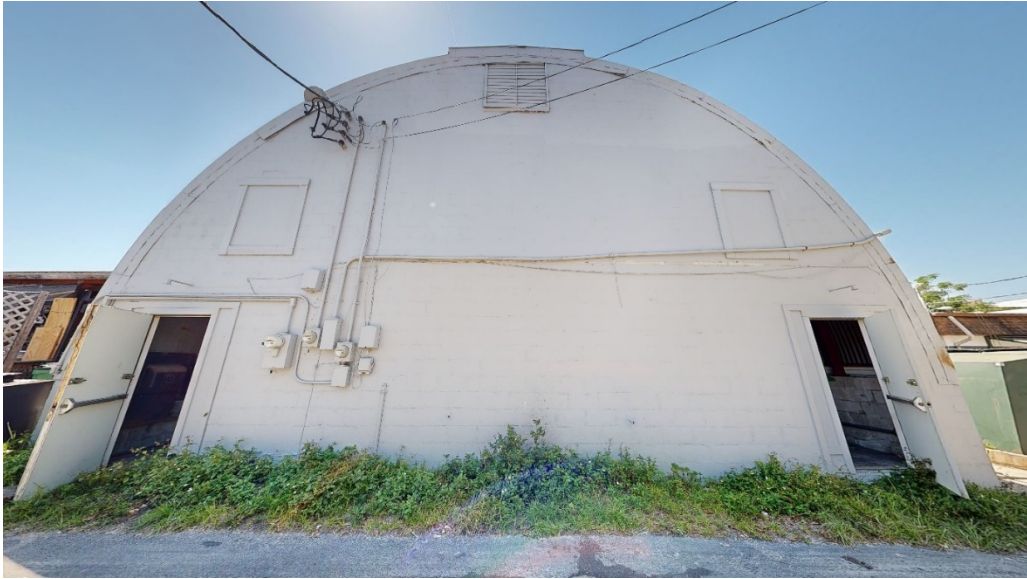
Image 19: Wrapping of corrugated metal material at rear of theater.

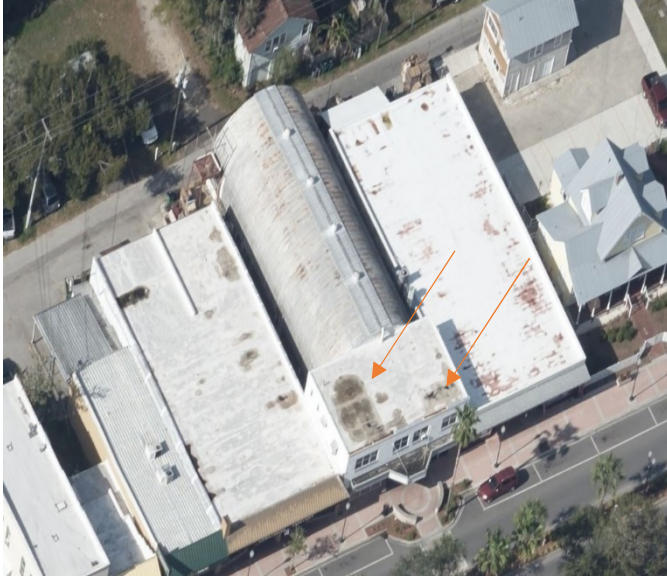
Image 21: Roof stains visible on membrane roof.

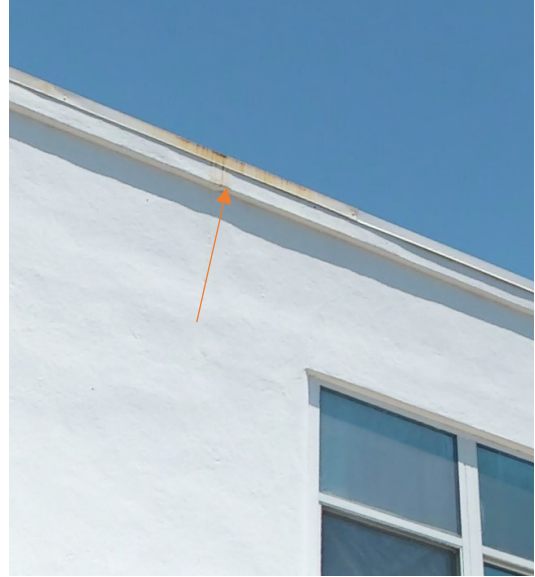
Image 22: Rusted, damaged roof flashing.

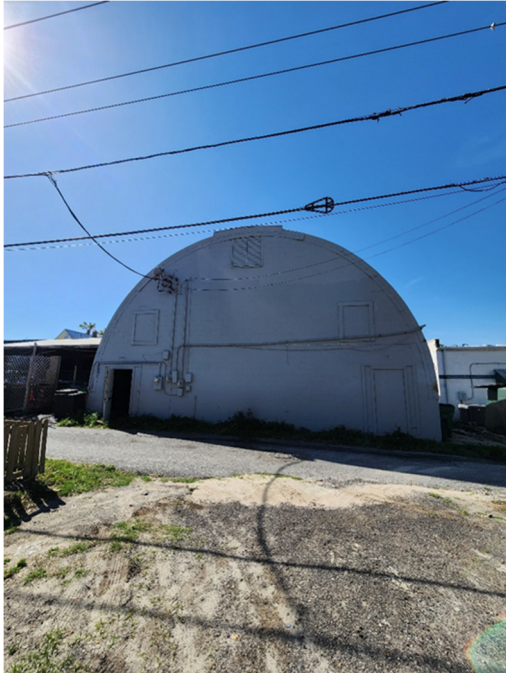
Image 1: North Elevation of Quonset Hut

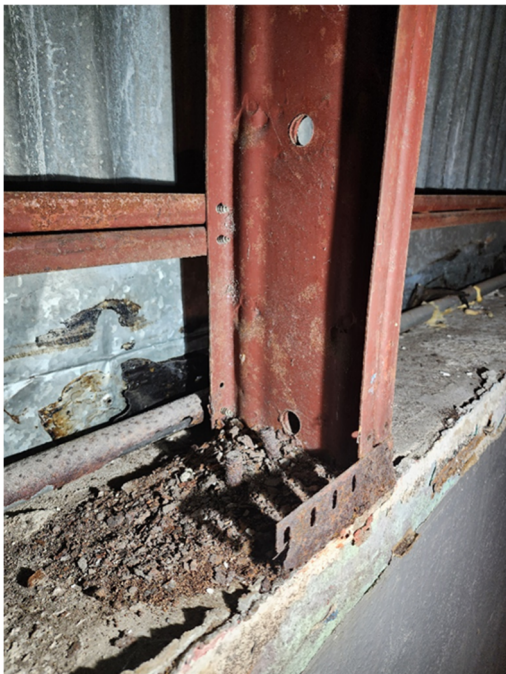
Image 3: Fully deteriorated base of Quonset frame connection.

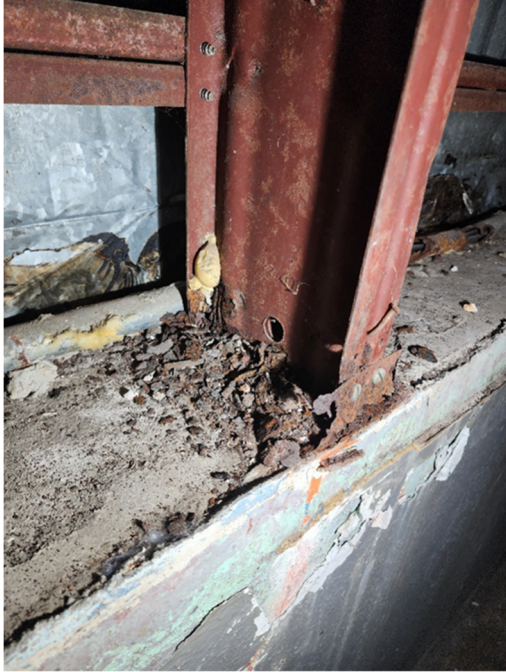
Image 6: Fully deteriorated base of Quonset frame connection.

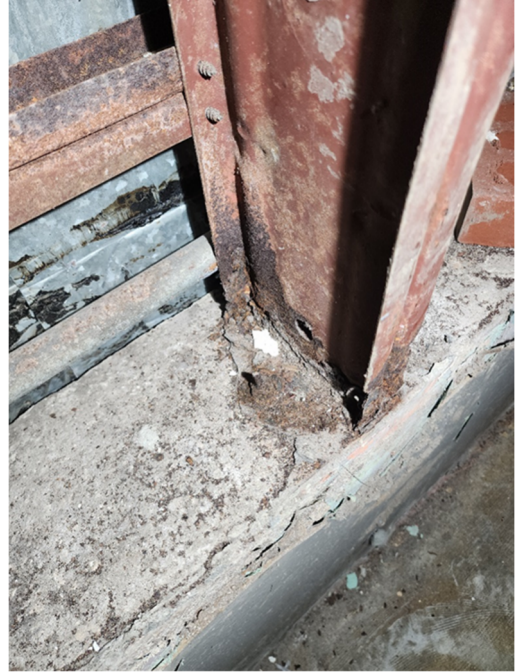
Image 7: Fully deteriorated base of Quonset frame connection.

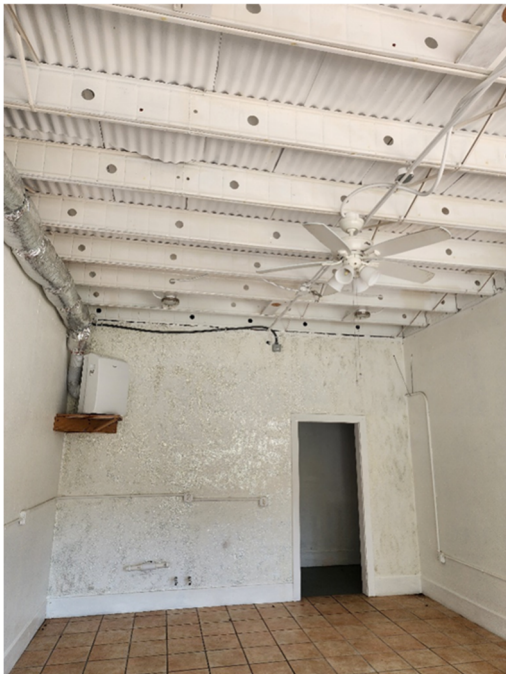
Image 8: Retail 2 Area. Second Floor framing above.

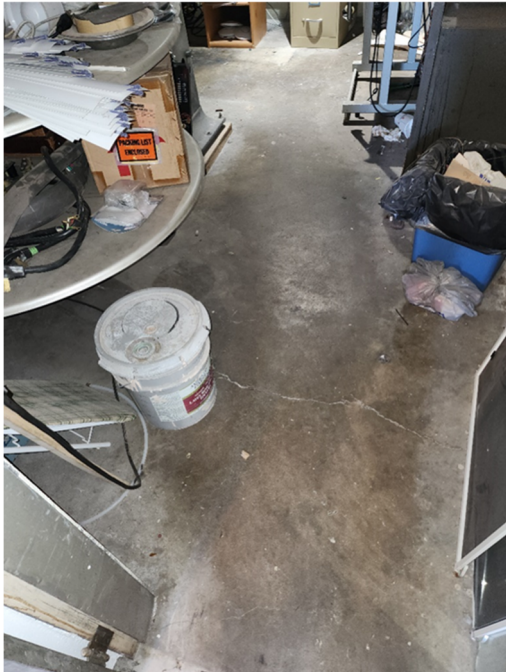
Image 13: Slab crack in Projection Room 2

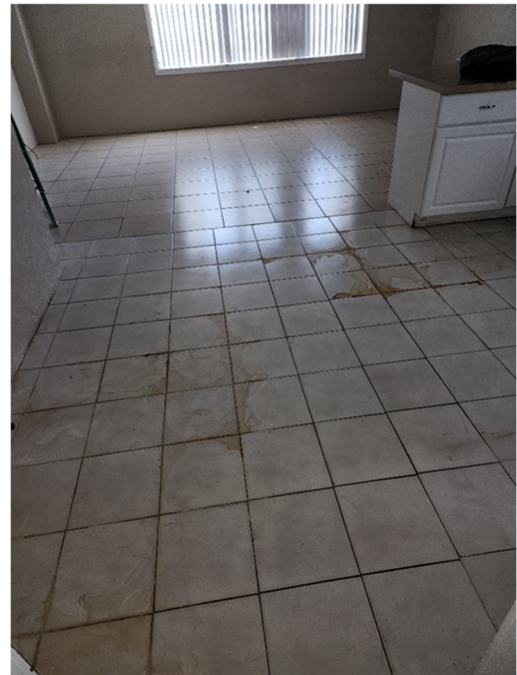
Image 14: Tile sloping in Apartment 2

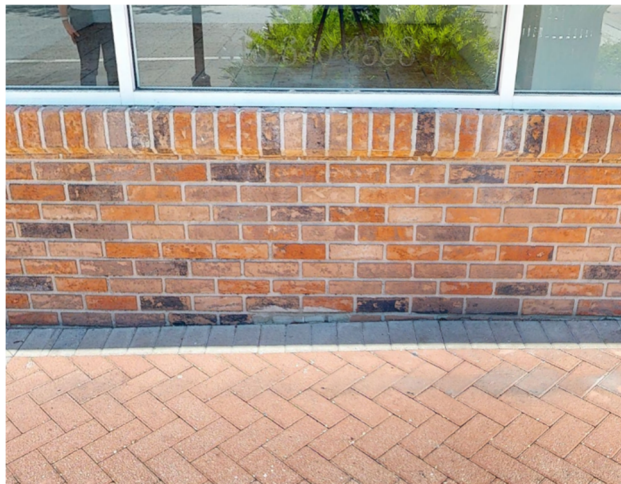
Image 3: Masonry patch material.

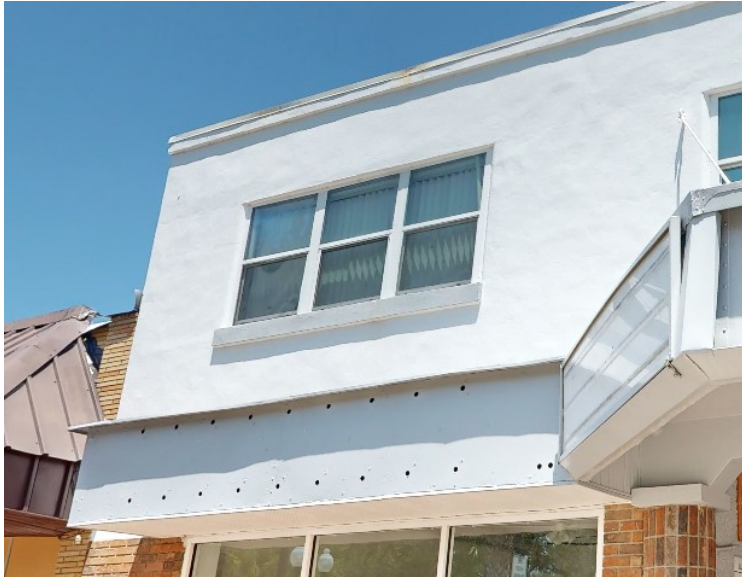
Image 15: Smooth second floor stucco finish.

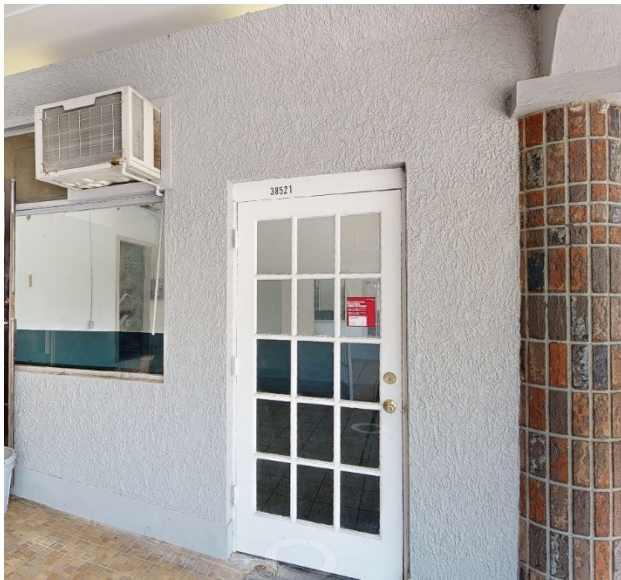
Image 17: Artistically textured stucco.

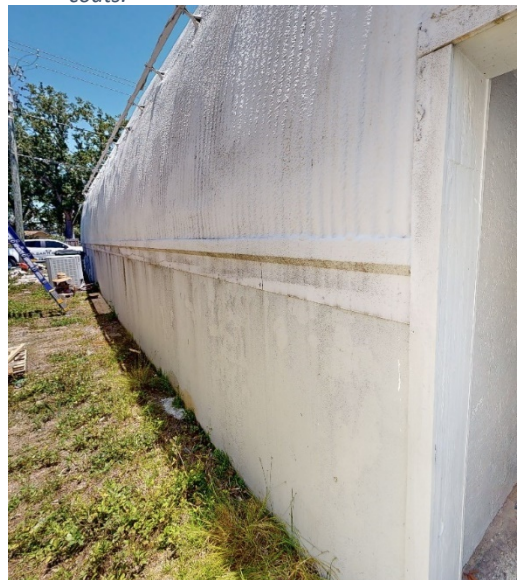
Image 18: Failing stucco and CMU Quonset Hut.

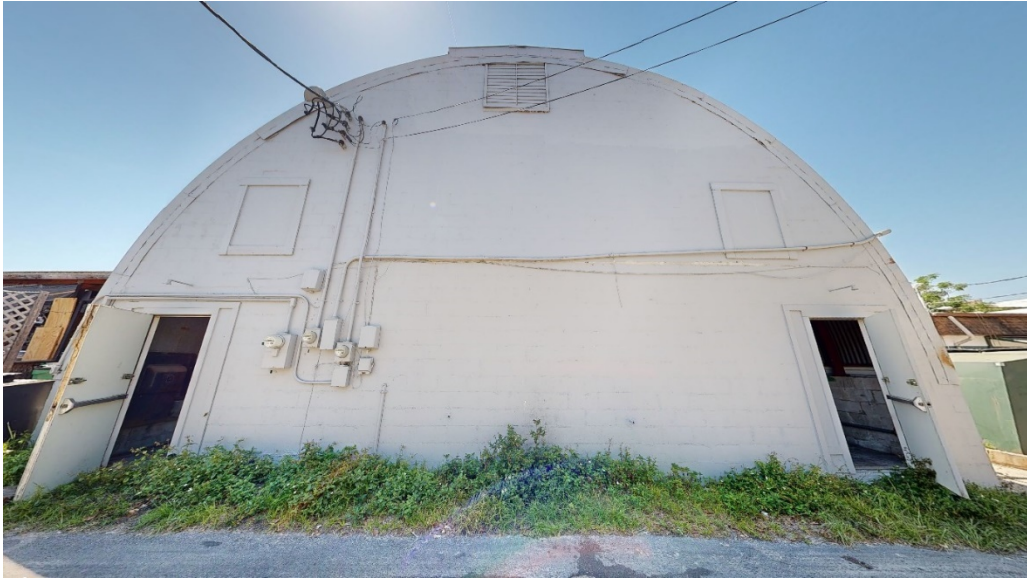
Image 19: Wrapping of corrugated metal material at rear of theater.

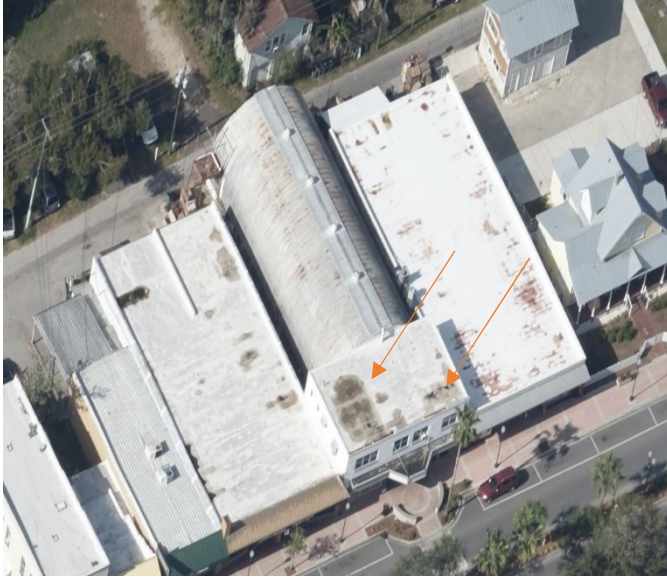
Image 21: Roof stains visible on membrane roof.

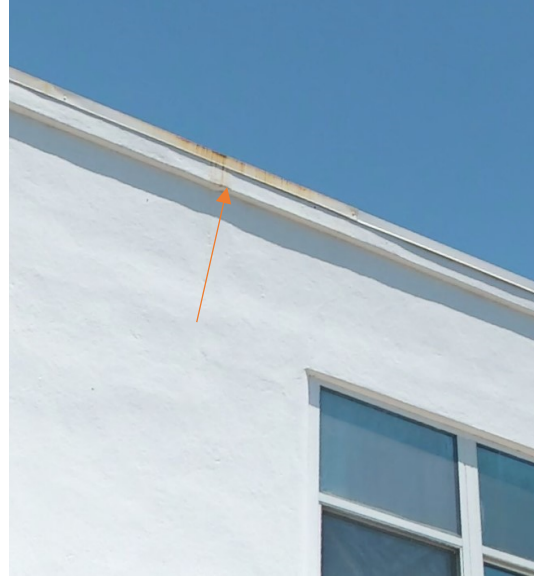
Image 22: Rusted, damaged roof flashing.

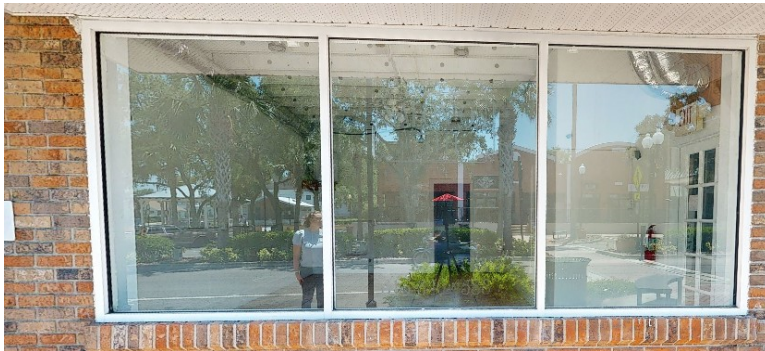
Image 23: Retail 2 front window.

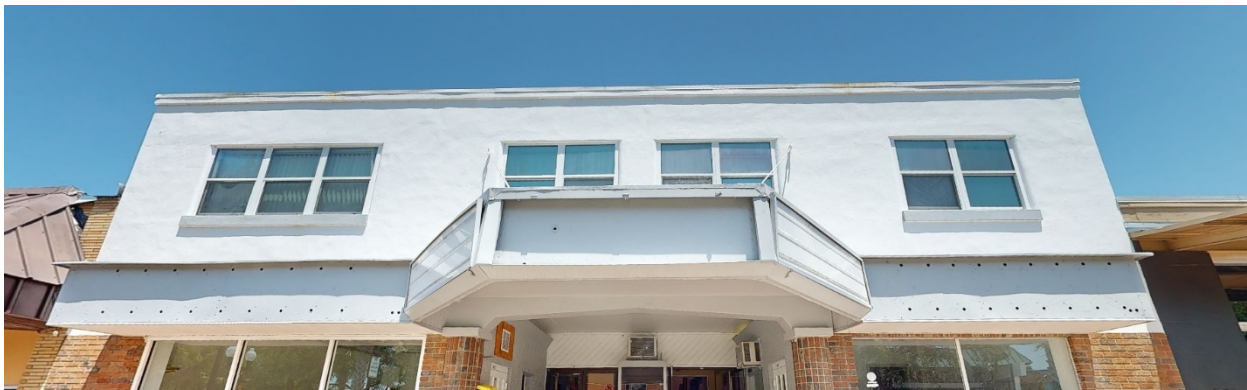
Image 27: Structurally failing marquee sign.

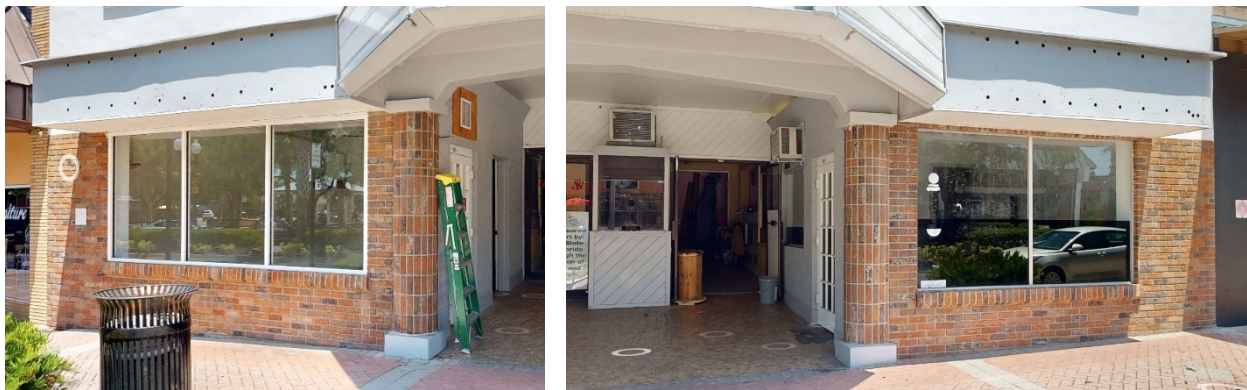
Image 28 & 29: Street approach to theater.

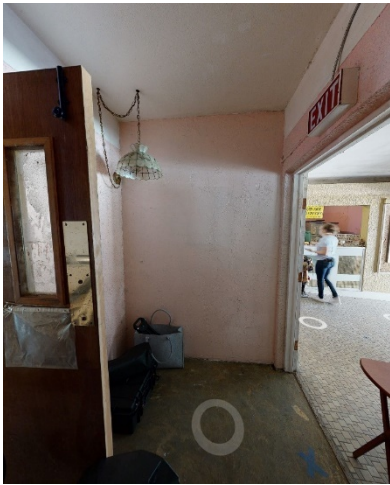
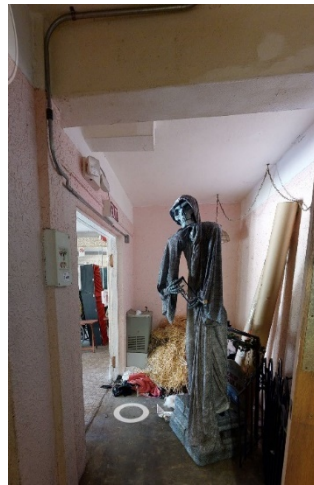
Image 36 & 37: Theater foyers.

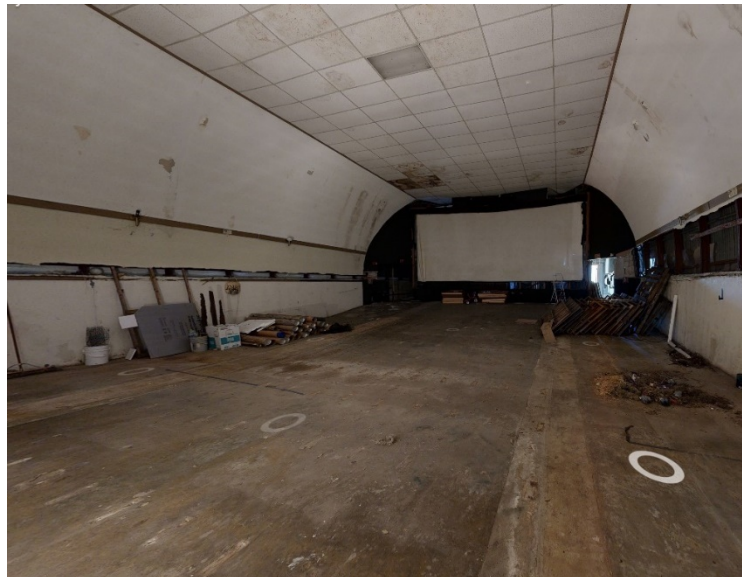
Inside Theater 1, the full height of the Quonset hut is utilized, with an acoustic tile ceiling installed at the top of the arch. These ceiling tiles exhibit significant staining and damage throughout. The curved steel walls retain remnants of finish material but are heavily stained with biological growth and show widespread rust staining. As with the

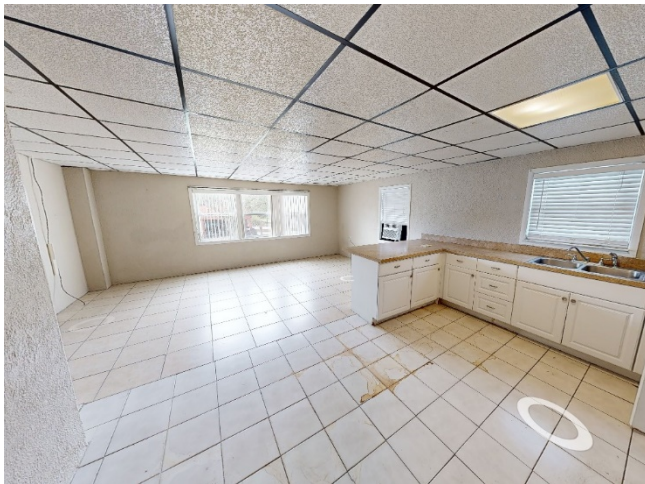
Image 42: Current condition of both apartments.

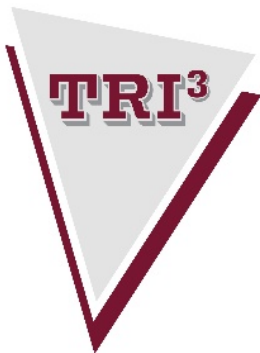
PART D – CIVIL EVALUATION

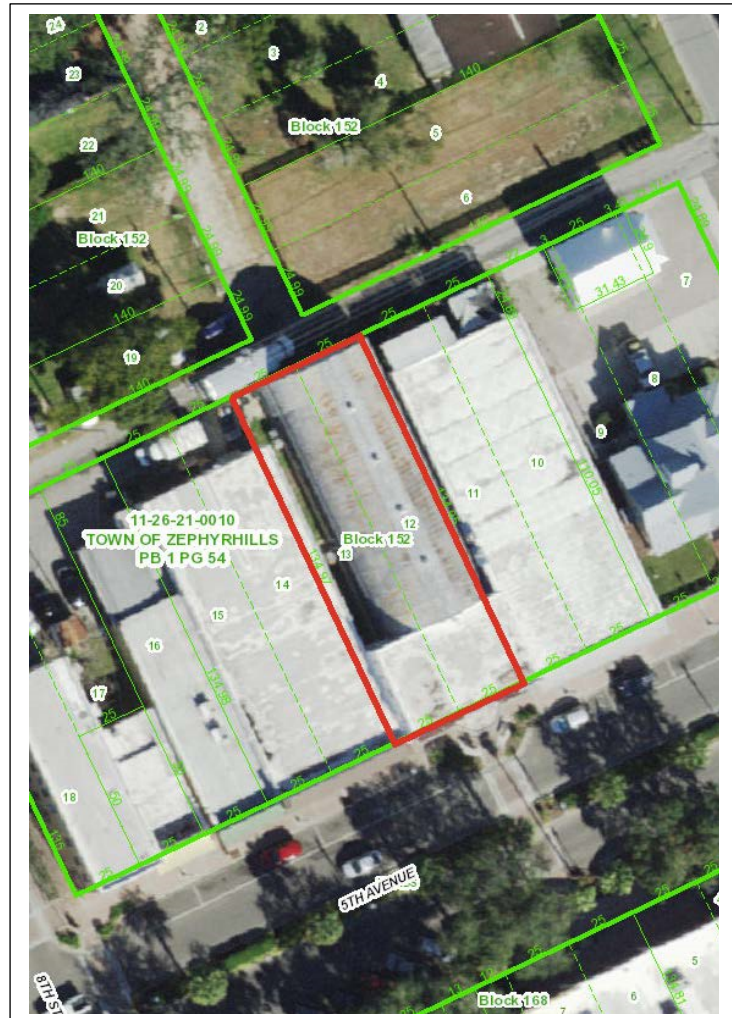
The Zephyrhills Main Street Theatre project is located at 38521 5th Avenue, within the city limits of Zephyrhills, Florida. The theatre is situated on lots 12 and 13 of block 152 and is approximately 0.16 acres in size. There is an existing unnamed public alley along the rear of the theatre. The associated parcel ID is 11-26-21-0010-15200-120. Refer to **Figure D-1**. This part of the assessment will summarize existing site conditions and proposed demolition activities to be performed as Phase I of this project.

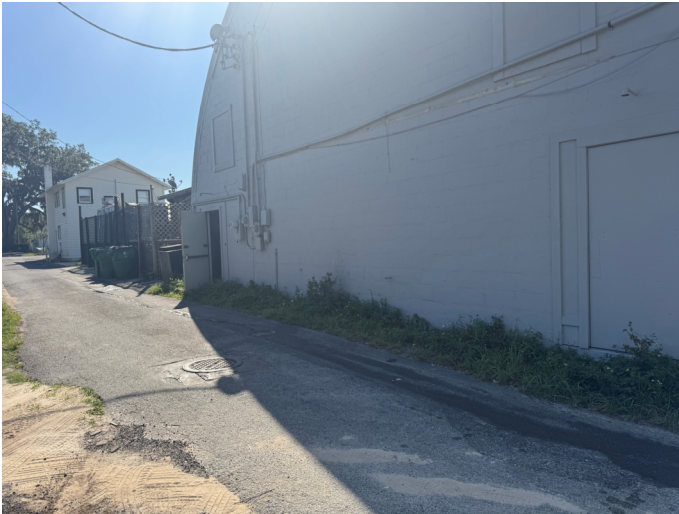
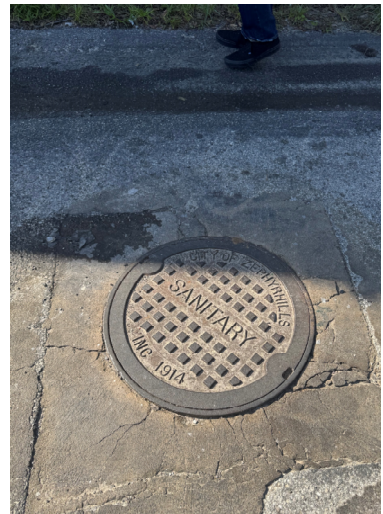
There are two (2) concrete pads that are used for existing air conditioning units, both of which appear to be connected to the existing theatre buildings.

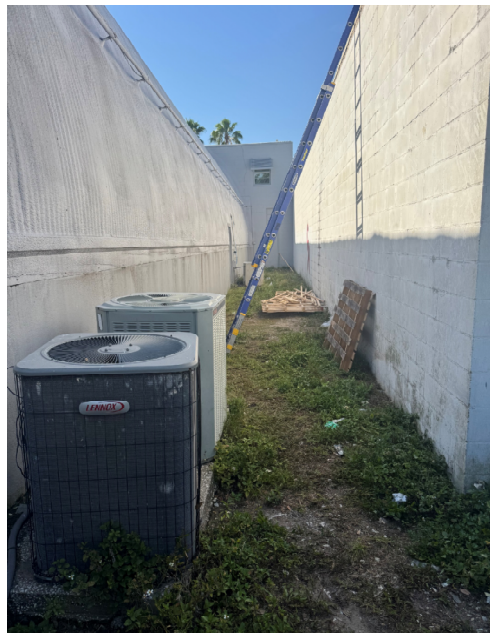
There is an existing concrete pad at the northwest rear corner of lot 12 that is used for trash can receptacle pick-up.

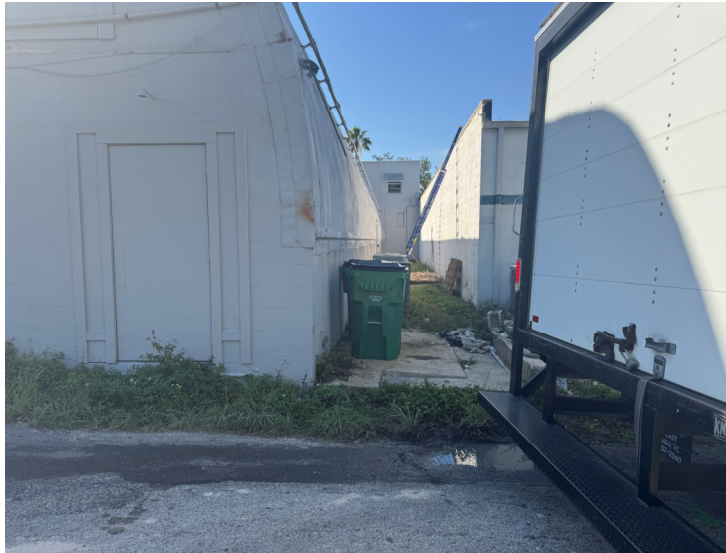
Phase I Site Demolition:

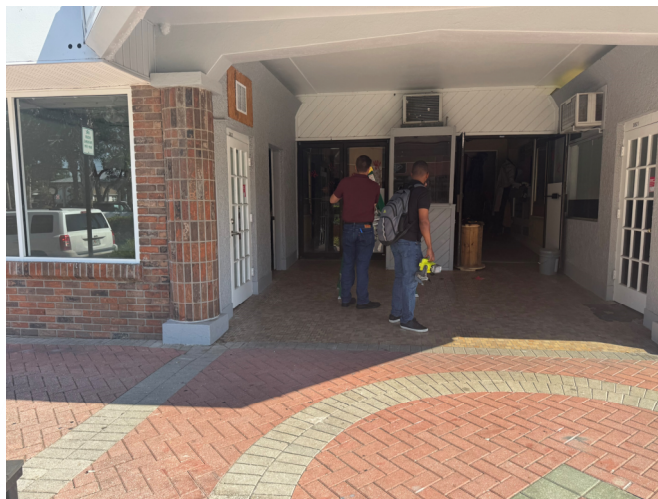
PART E – STRUCTURAL EVALUATION

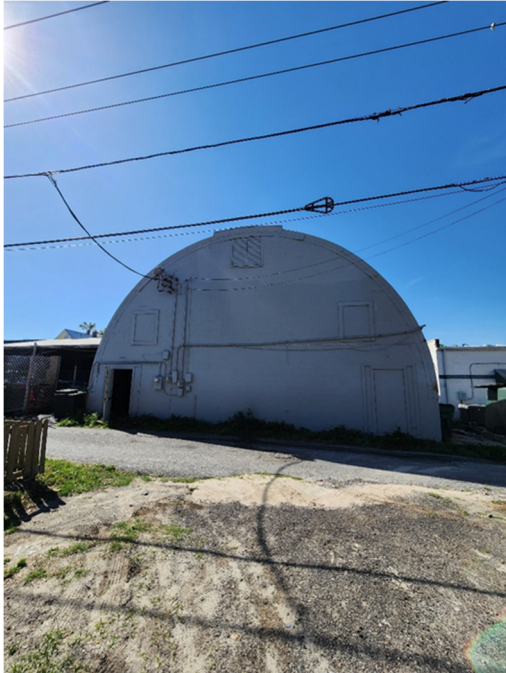
Image 1: North Elevation of Quonset Hut

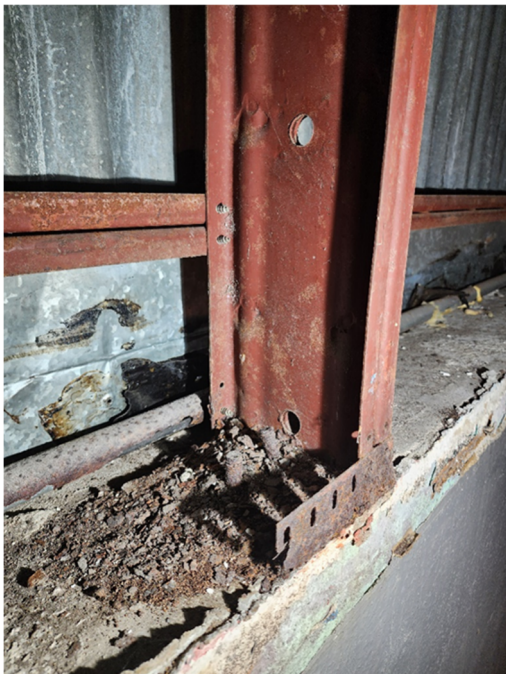
Image 3: Fully deteriorated base of Quonset frame connection.

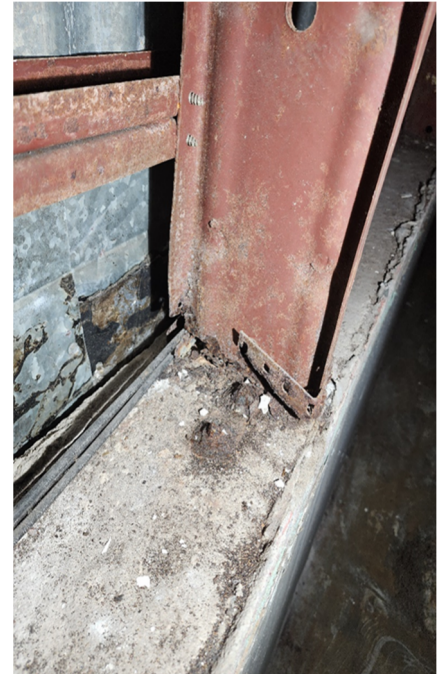
Image 5: Fully deteriorated base of Quonset frame connection.

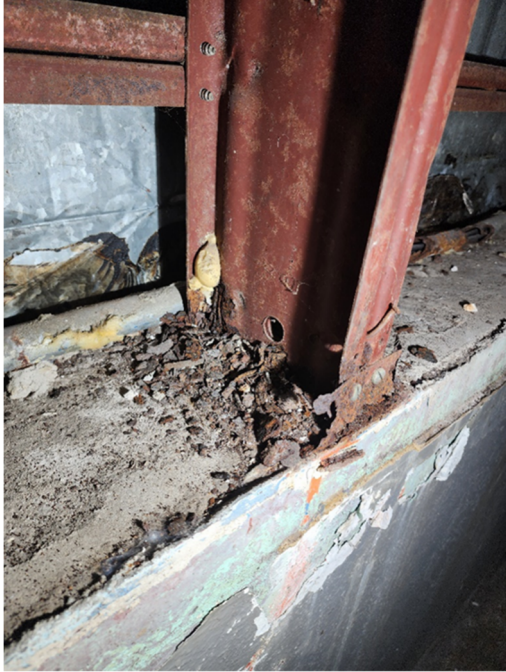
Image 6: Fully deteriorated base of Quonset frame connection.

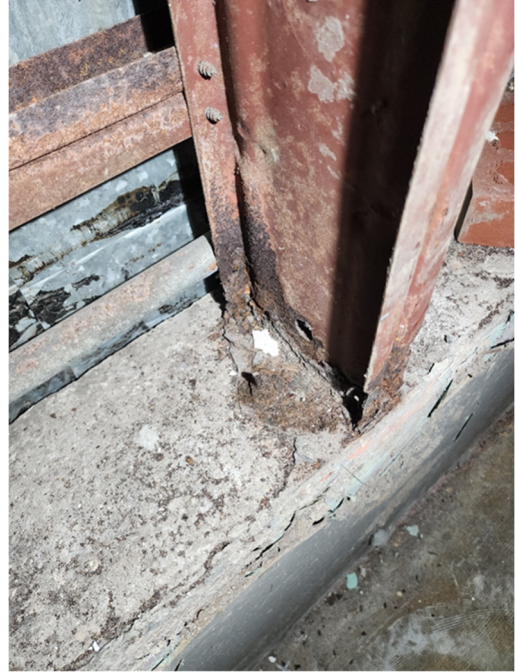
Image 7: Fully deteriorated base of Quonset frame connection.

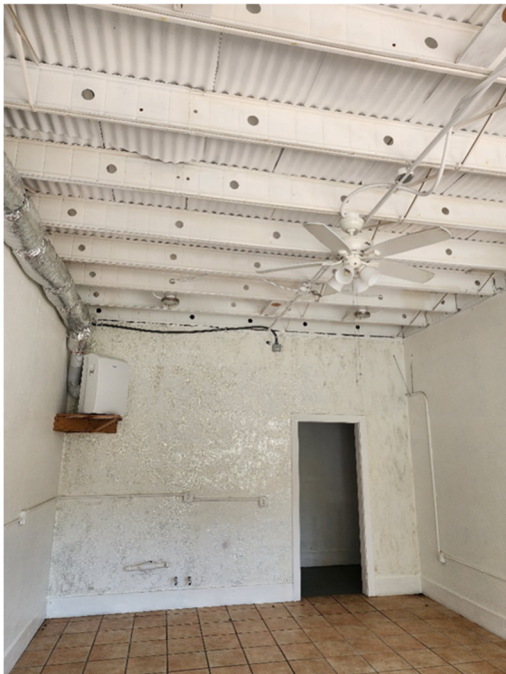
Image 8: Retail 2 Area. Second Floor framing above.

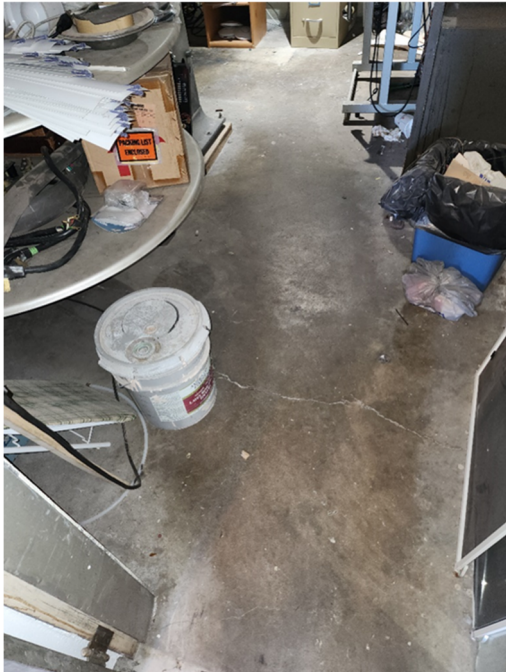
Image 13: Slab crack in Projection Room 2

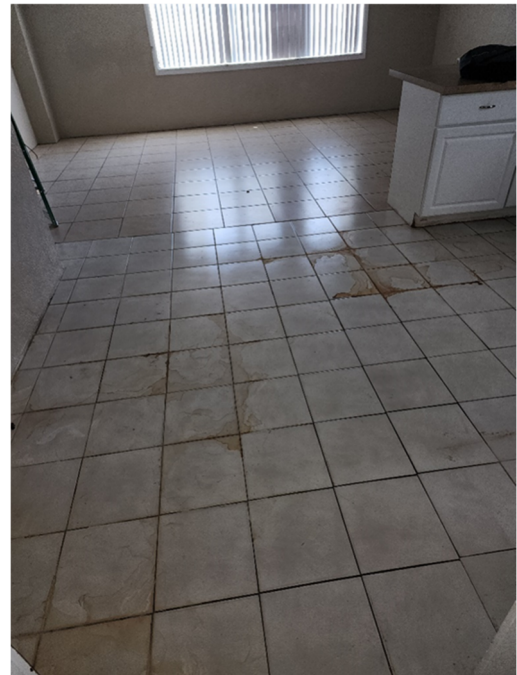
Image 14: Tile sloping in Apartment 2

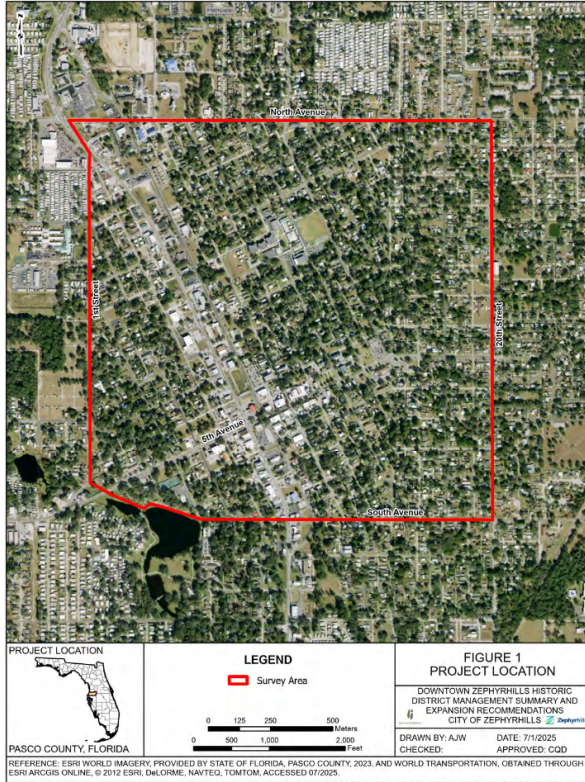
GAI surveyed the existing Historic District boundary as well as the surrounding neighborhood with North Ave, South Ave, 1st St, and 20th St acting as the boundaries for the survey. (See Figure 1)

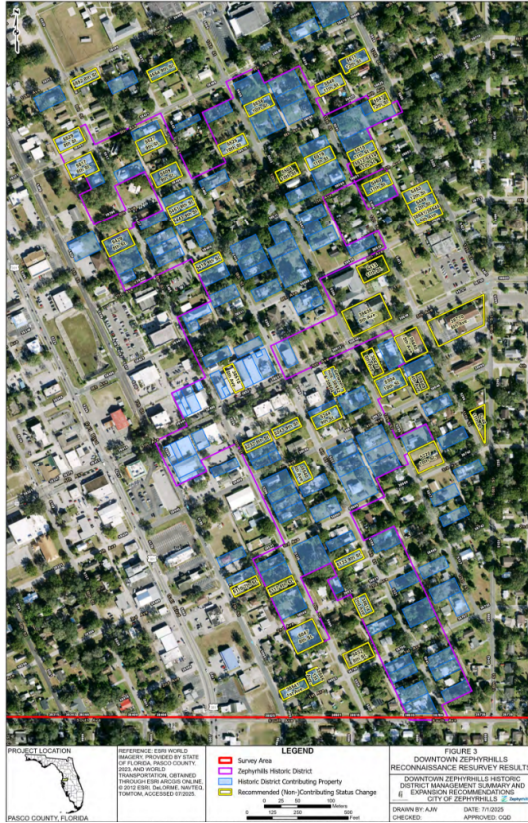
- The properties proposed to have their Contributing status changed are highlighted in yellow in Figure 3.
- 23 properties are proposed to change from Contributing to Non-Contributing.
- 6 properties are proposed to change from Non-Contributing to Contributing.
- 10 directly adjacent properties that could be categorized as Contributing are proposed to be added to the District.

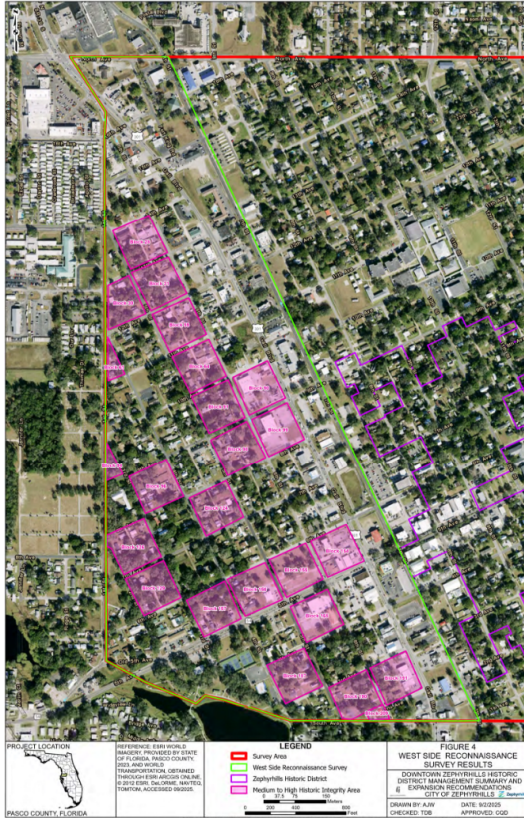
- Expand the period of significance from 1910 to 1975 (currently from 1910 to 1950).
- Perform an additional, intensive-level survey of the blocks west of 7th Street to evaluate expanding district to the west or creating a new Historic Preservation District to include the blocks indicated in Figure 4.
- Revise the status of 23 structures within the District from Contributing to Non-Contributing and 6 from Non-Contributing to Contributing.

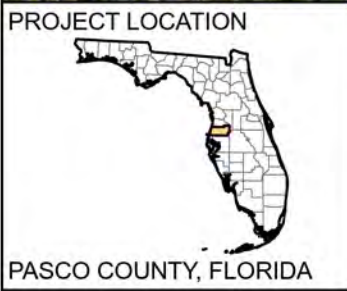
FIGURE 1
PROJECT LOCATION

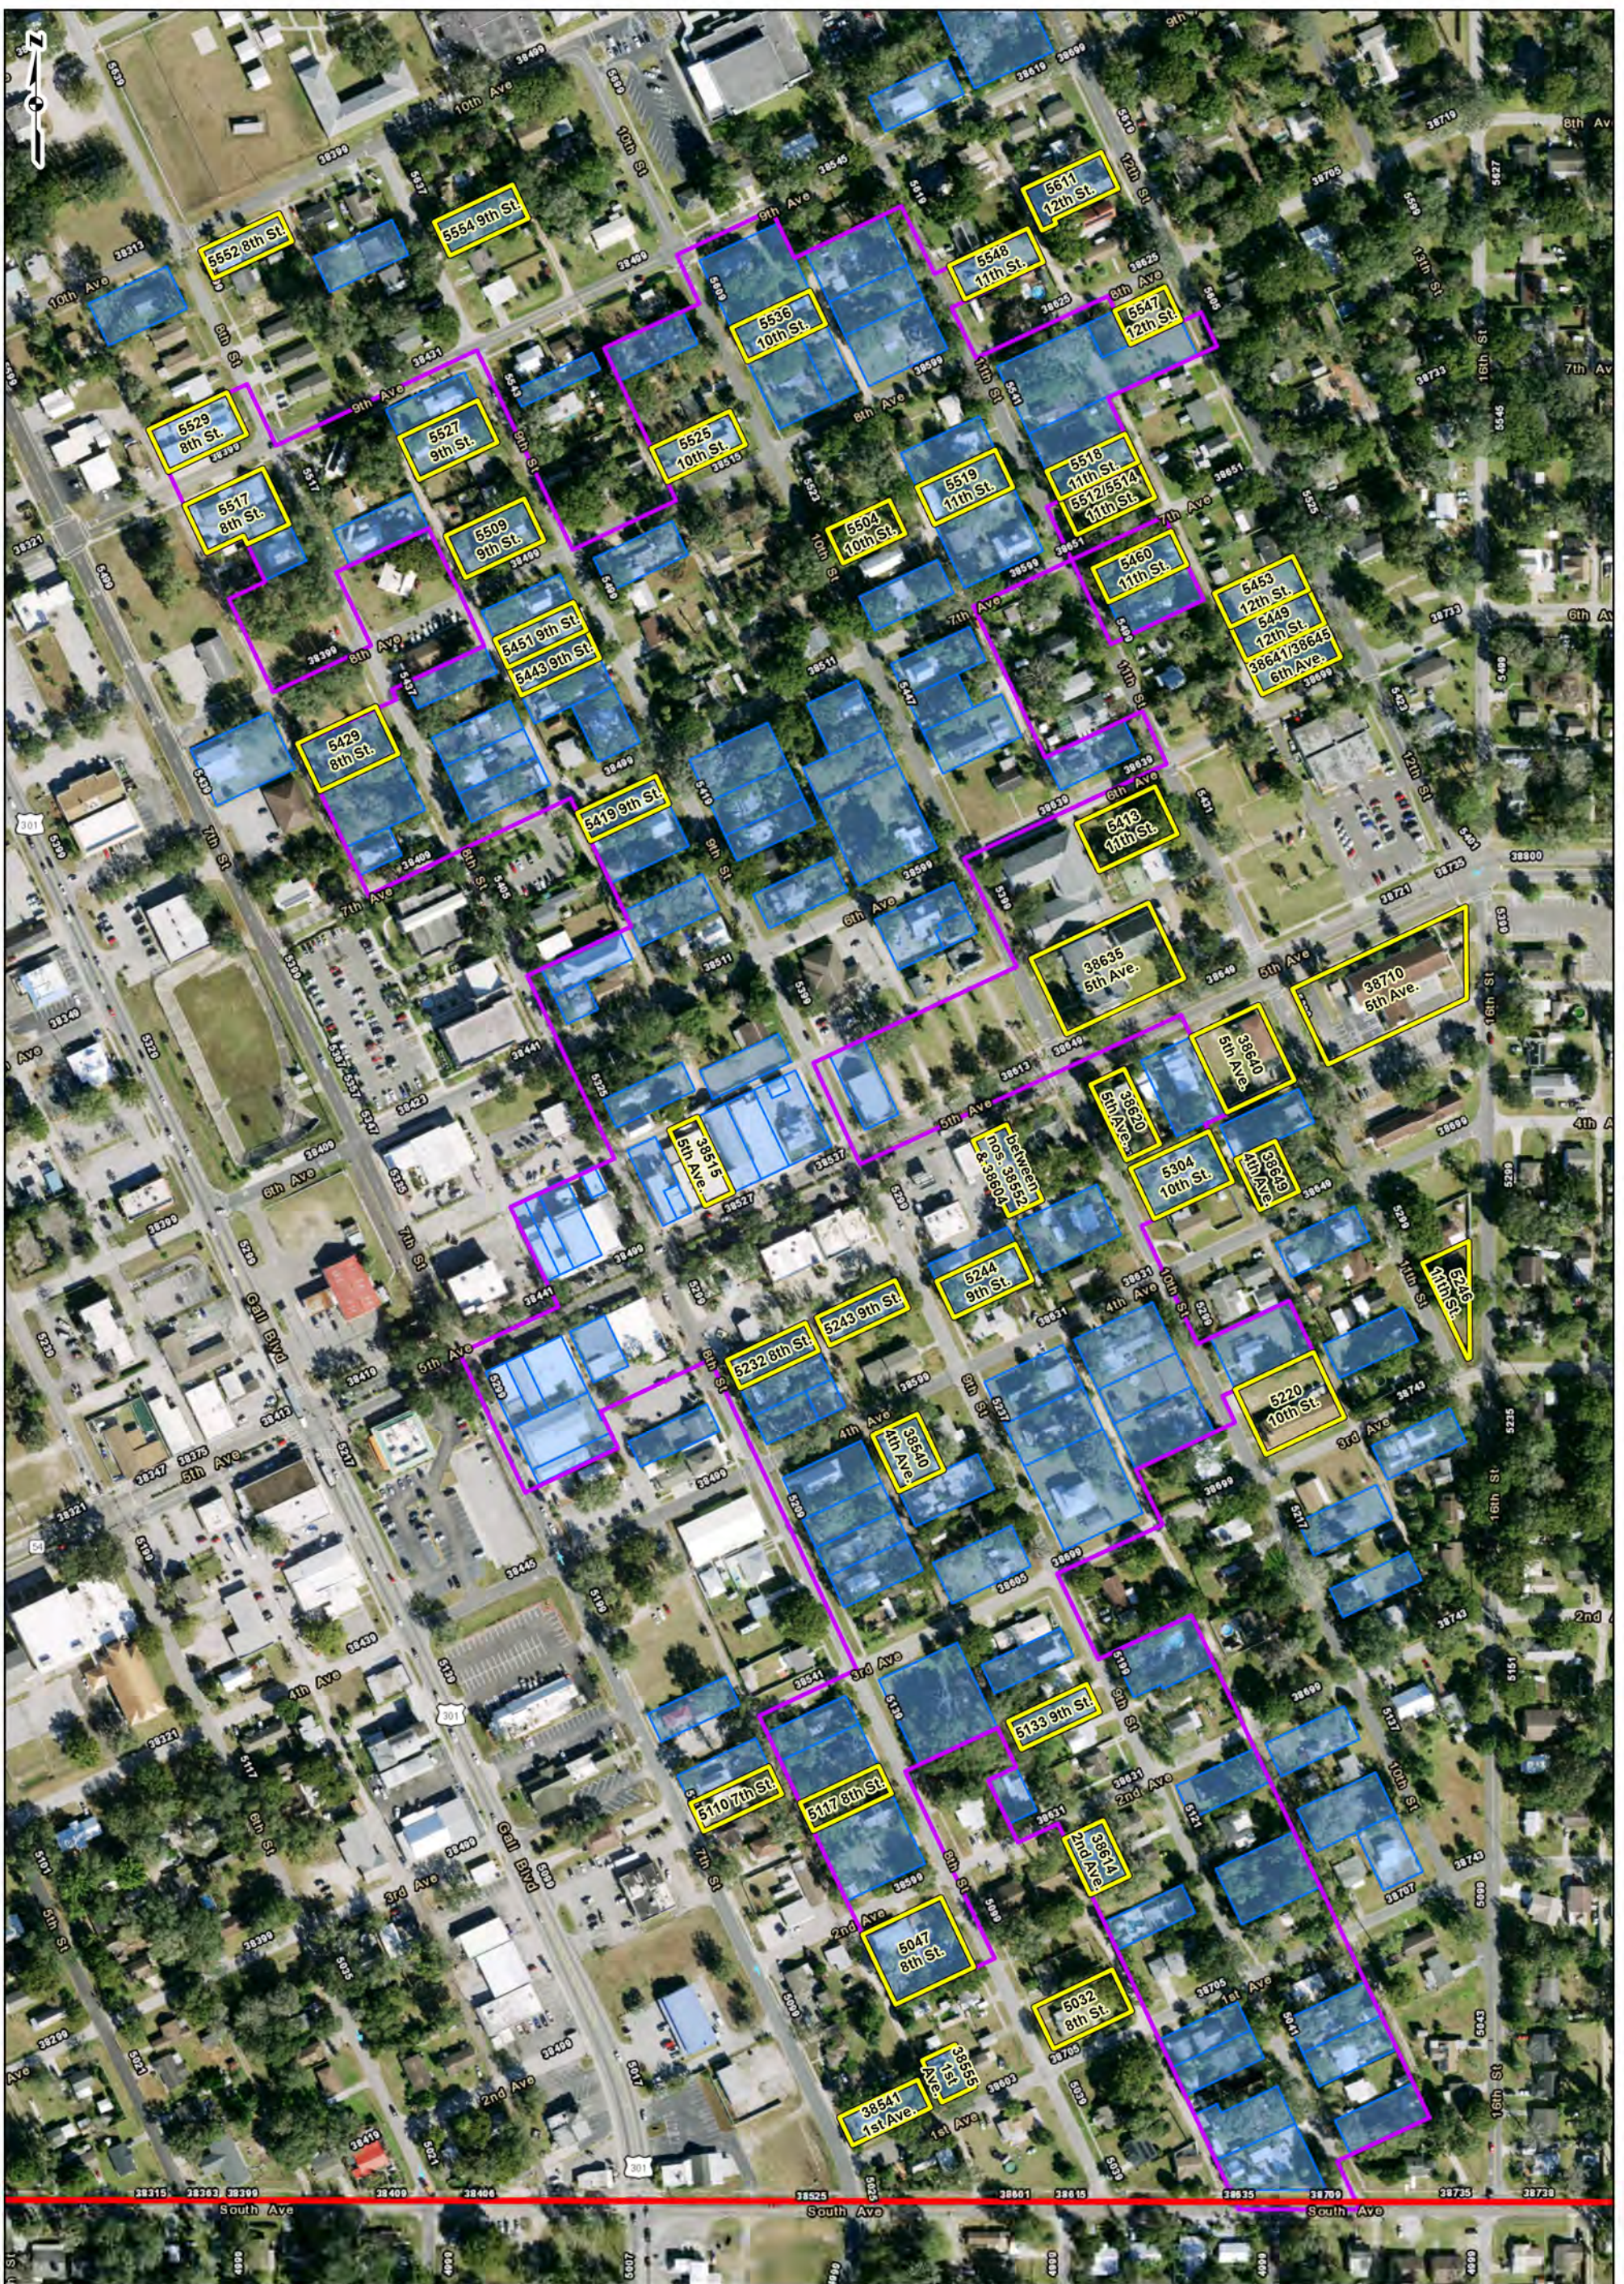
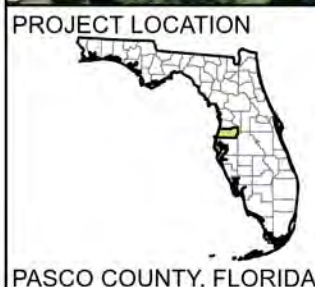
REFERENCE: ESRI WORLD IMAGERY PROVIDED BY STATE OF FLORIDA, PASCO COUNTY, 2023, AND WORLD TRANSPORTATION, OBTAINED THROUGH ESRI ARCGIS ONLINE, © 2012 ESRI, DeLORME, NAVTEQ, TOMTOM, ACCESSED 07/2025.

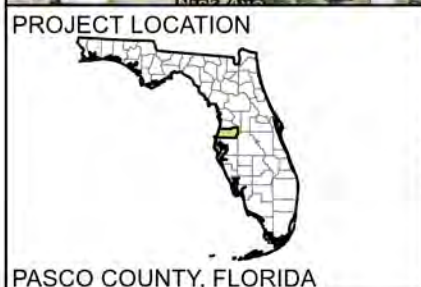
REFERENCE: ESRI WORLD IMAGERY, PROVIDED BY STATE OF FLORIDA, PASCO COUNTY, 2023, AND WORLD TRANSPORTATION, OBTAINED THROUGH ESRI ARCGIS ONLINE, © 2012 ESRI, DeLORME, NAVTEQ, TOMTOM, ACCESSED 09/2025.

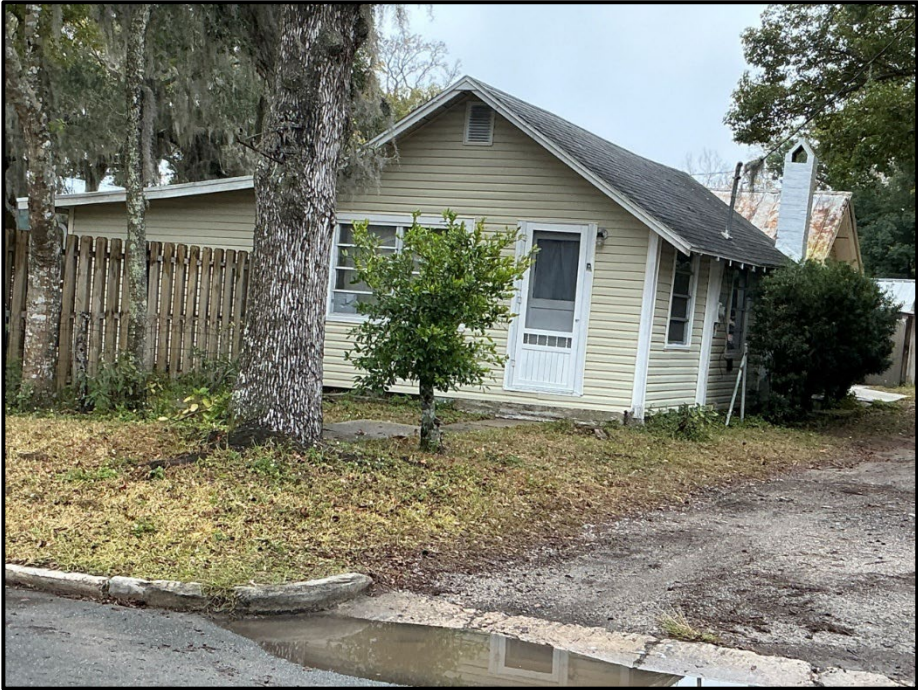
Photograph 1. 38540 4th Avenue; note vinyl siding and large side addition (recommended noncontributing).

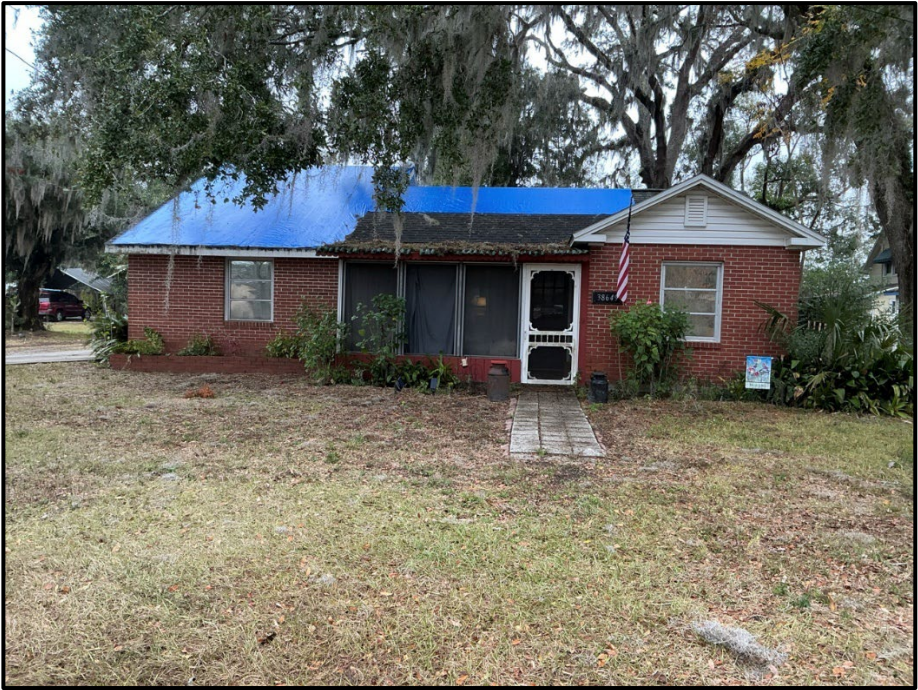
Photograph 2. 38649 4th Avenue; recommended contributing (adjacent to Downtown District).
