**HISTORIC PRESERVATION
ZEPHYRHILLS, FLORIDA**

**Thursday, October 30, 2025
6:00 PM**

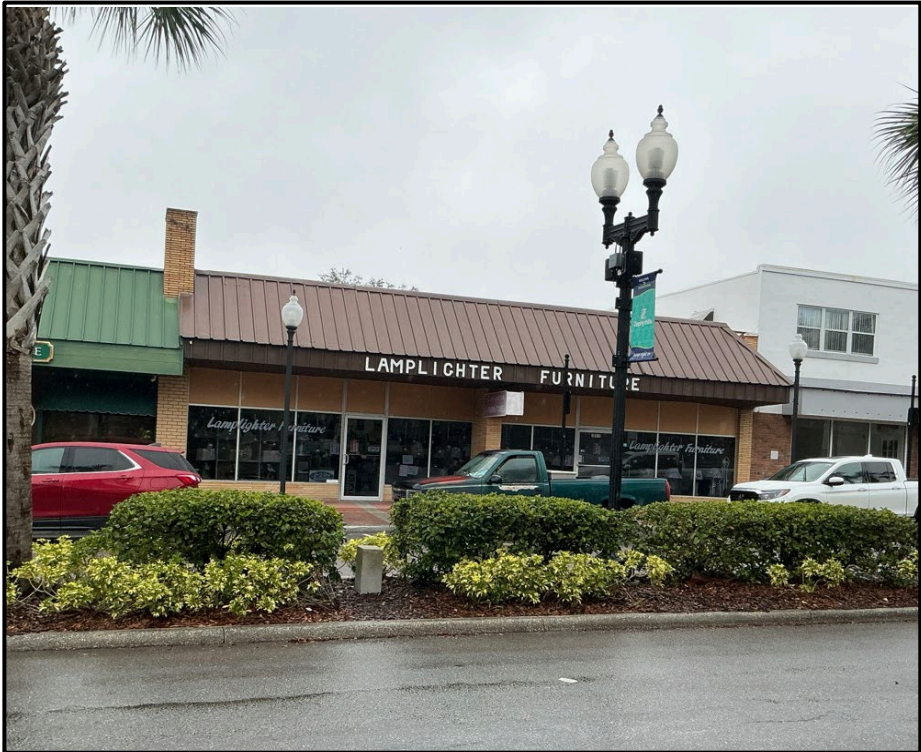
Photograph 3. 38515 5th Avenue; recommended contributing.

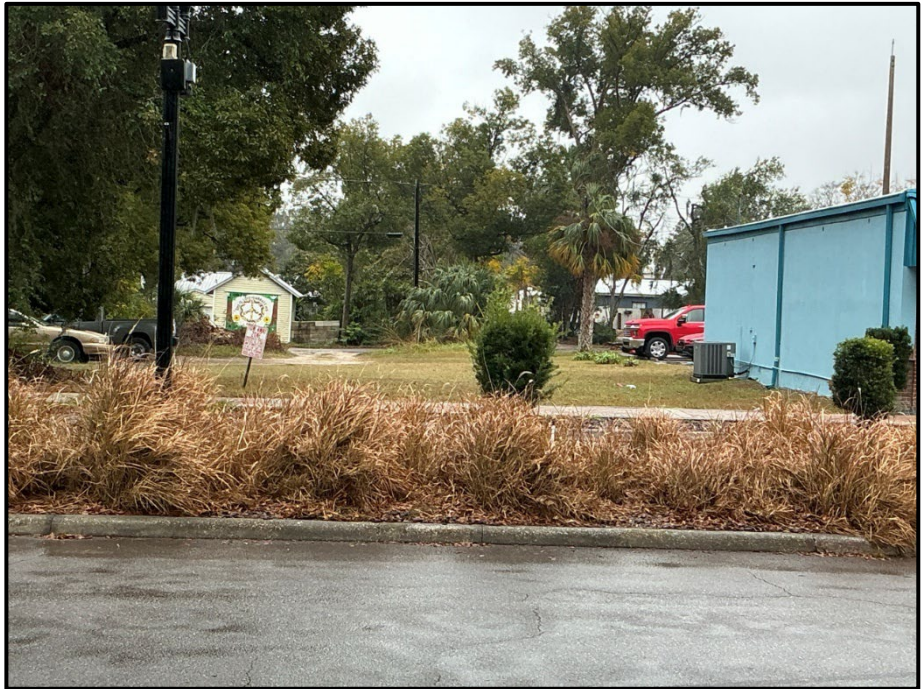
Photograph 4. South side 5th Avenue between 38552 and 38604; vacant lot (recommended noncontributing).

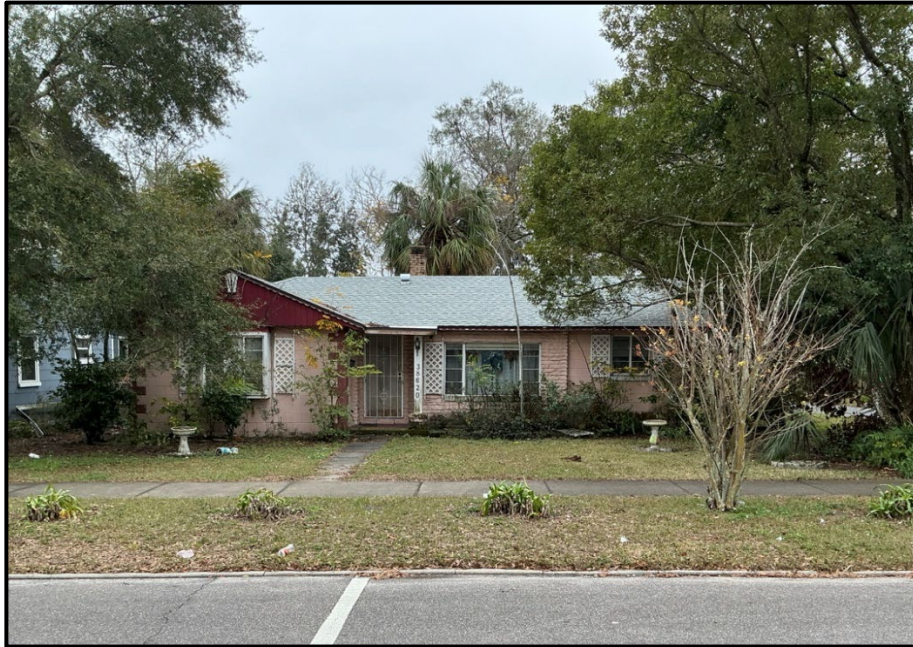
Photograph 5. 38620 5th Avenue; recommended contributing.

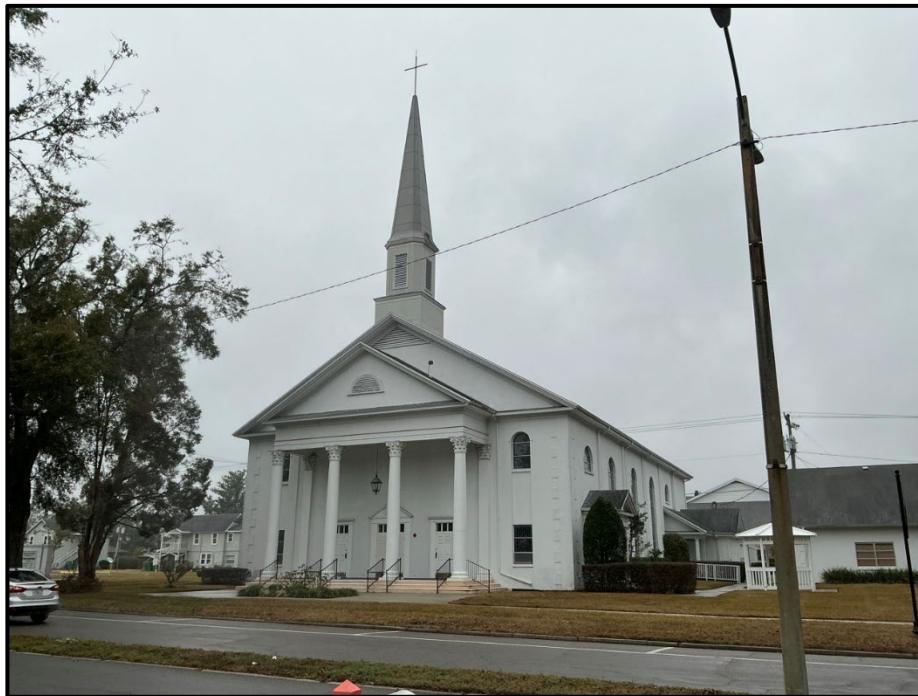
Photograph67. 38635 5th Avenue; recommended contributing (adjacent to Downtown District).

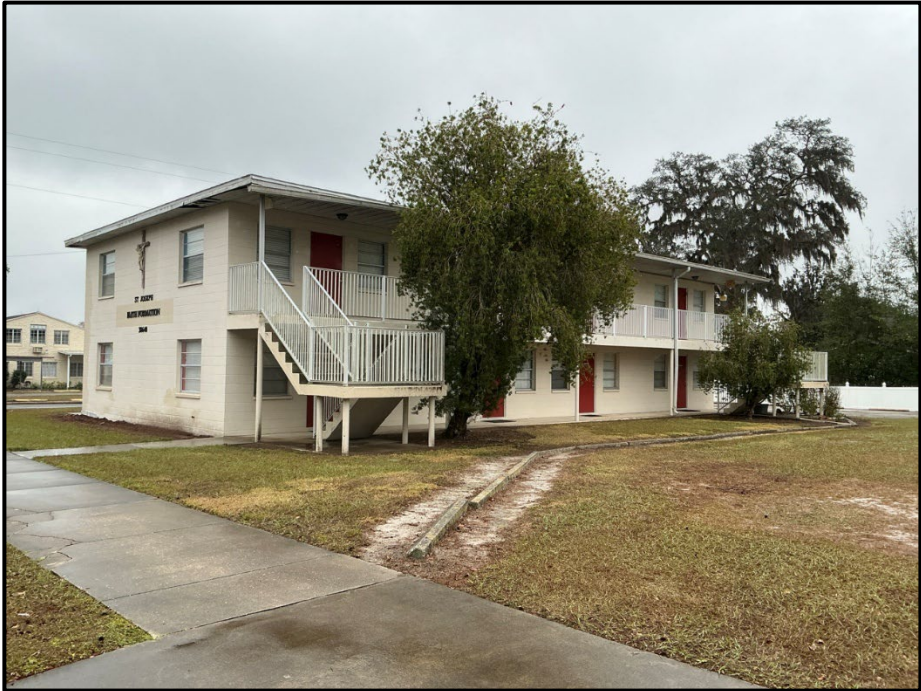
Photograph 7. 38640 5th Avenue; recommended contributing (adjacent to Downtown District).

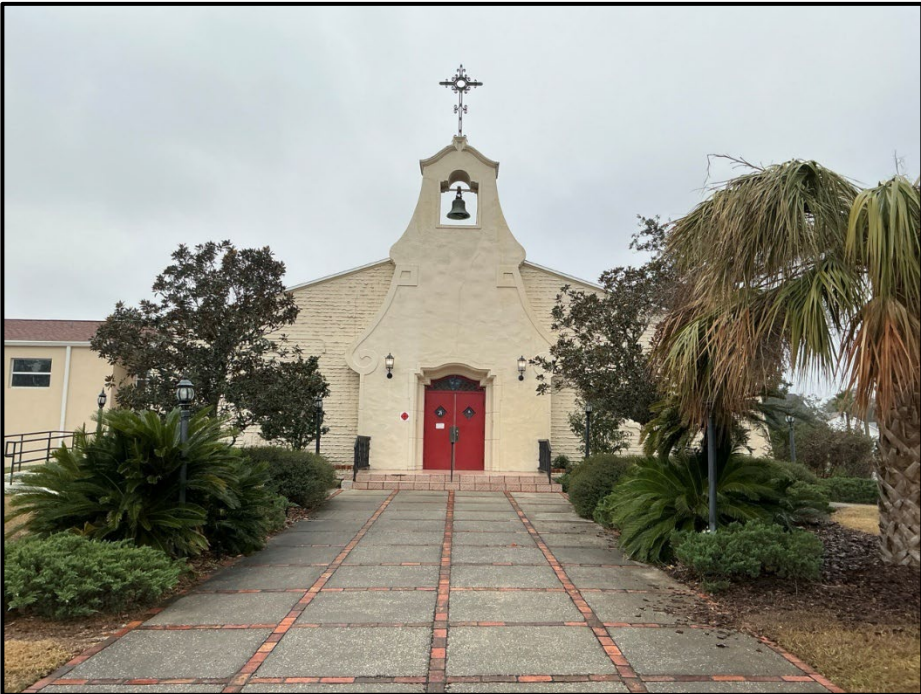
Photograph 8. 38710 5th Avenue; recommended contributing (adjacent to 38640 5th Avenue).

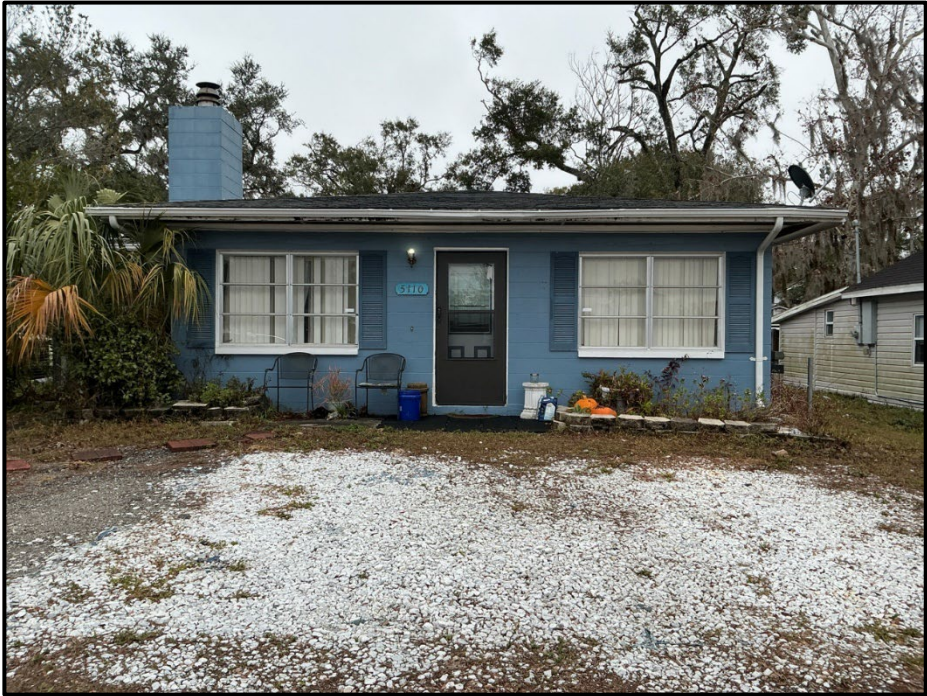
Photograph 9. 5110 7th Street; recommended contributing (adjacent to the Downtown District).

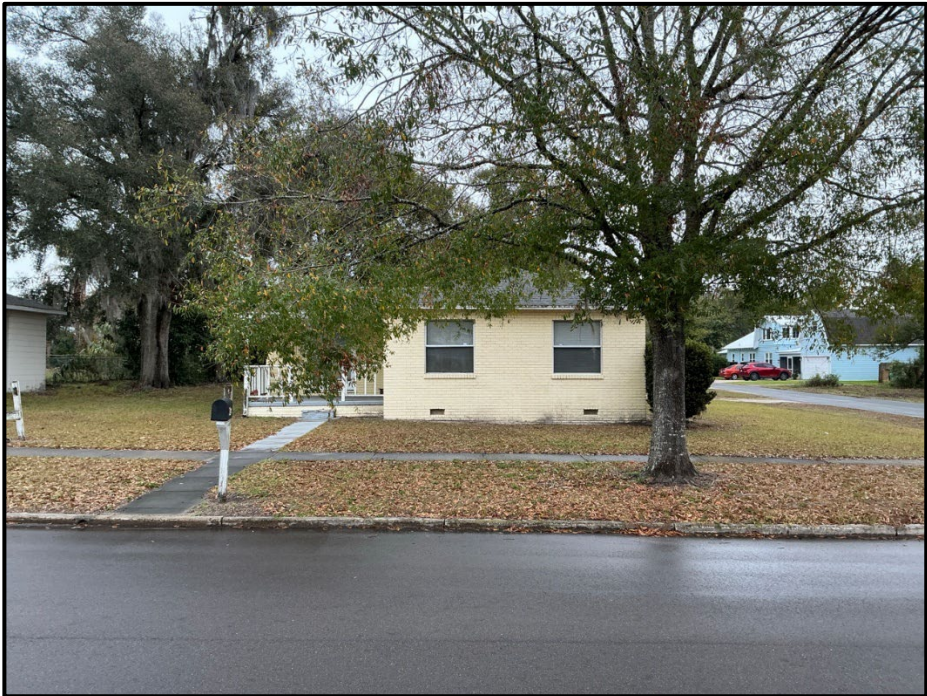
Photograph 10. 5032 8th Street; recommended contributing (adjacent to the Downtown District).

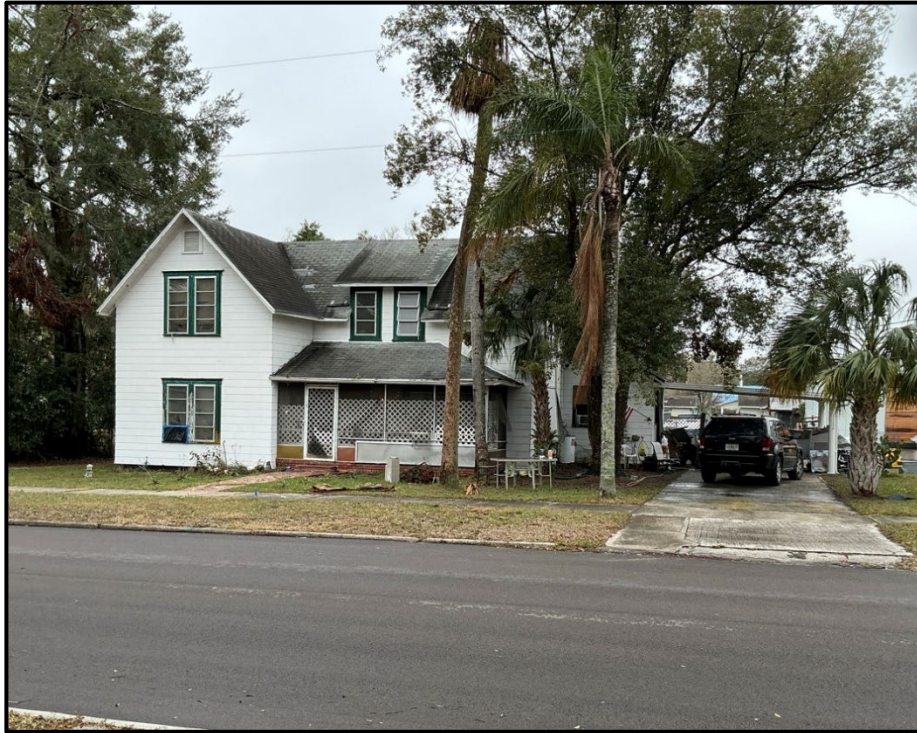
Photograph 11. 5047 8th Street; note incompatible replacement windows and non-historic carport (recommended noncontributing).

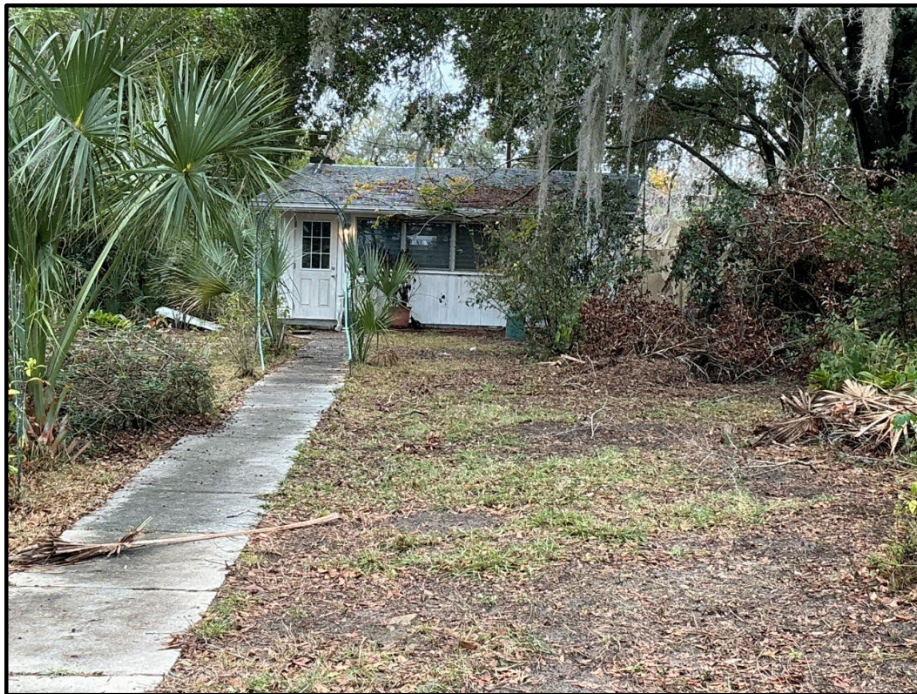
Photograph 12. 5117 8th Street; recommended contributing.

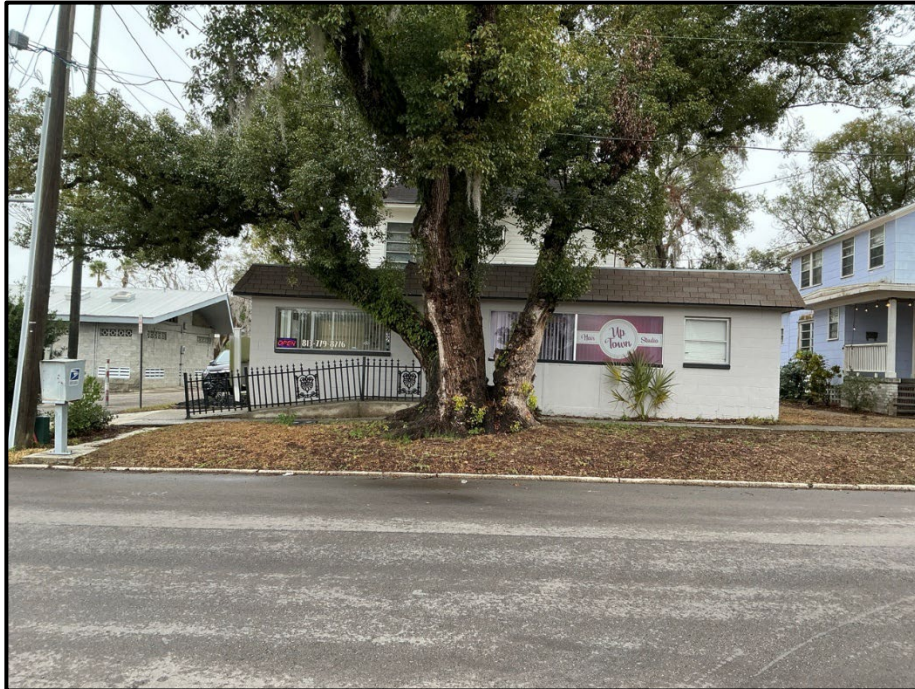
Photograph 13. 5232 8th Street; note obtrusive front additions and replacement windows (recommended noncontributing).

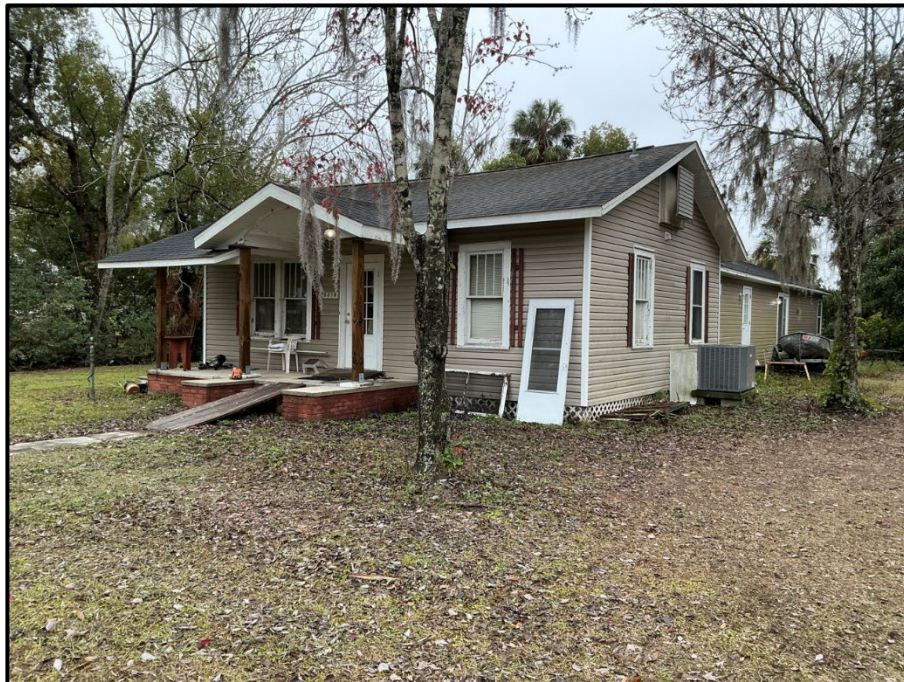
Photograph 14. 5429 8th Street; note vinyl siding, replacement porch posts, and large rear addition (recommended noncontributing).

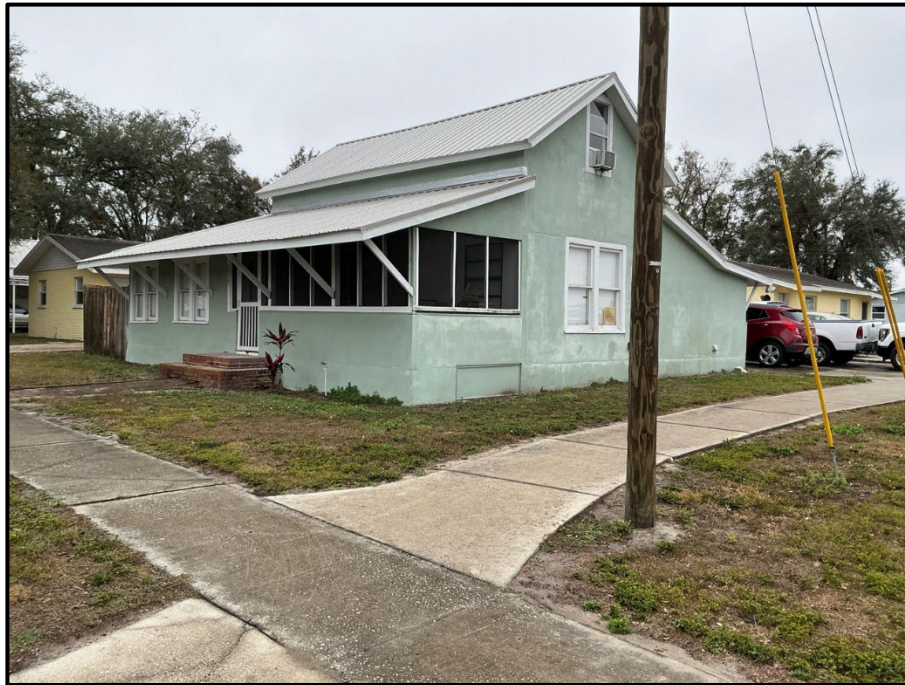
Photograph 15. 5517 8th Street; note non-historic stucco and rear porch enclosed ca. 2015 (recommended noncontributing).

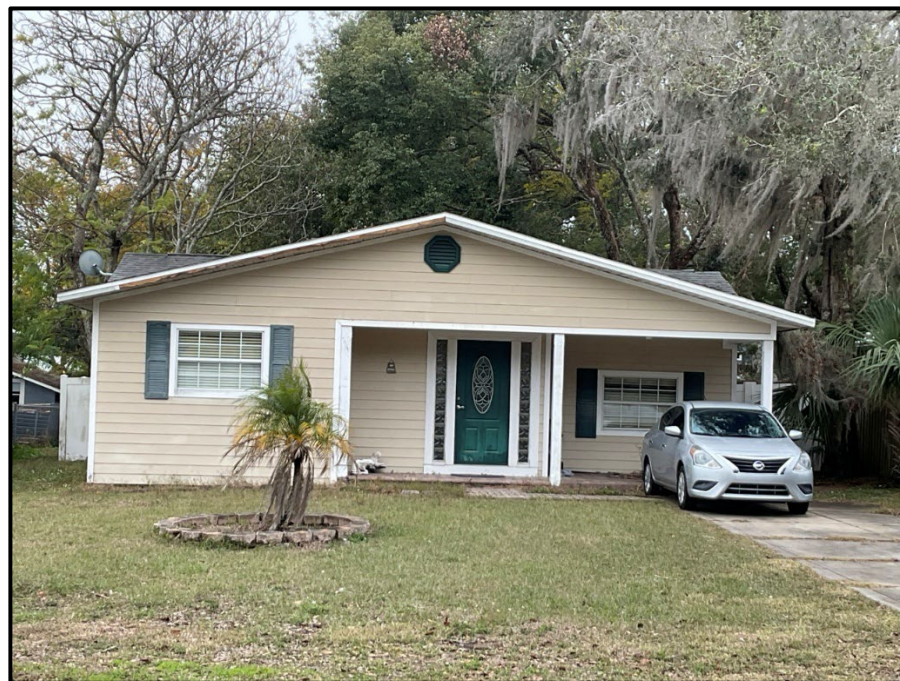
Photograph 16. 5133 9th Street; note synthetic siding, replacement windows, and incompatible front door (recommended noncontributing).

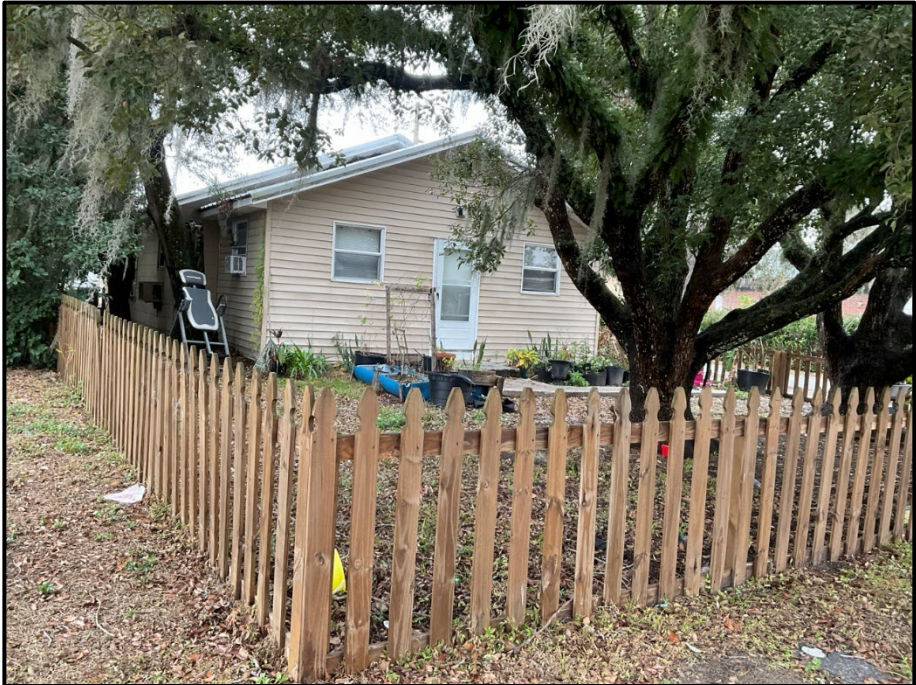
Photograph 17. 5423 9th Street; note enclosed front porch and vinyl siding applied ca. 2015 (recommended noncontributing).

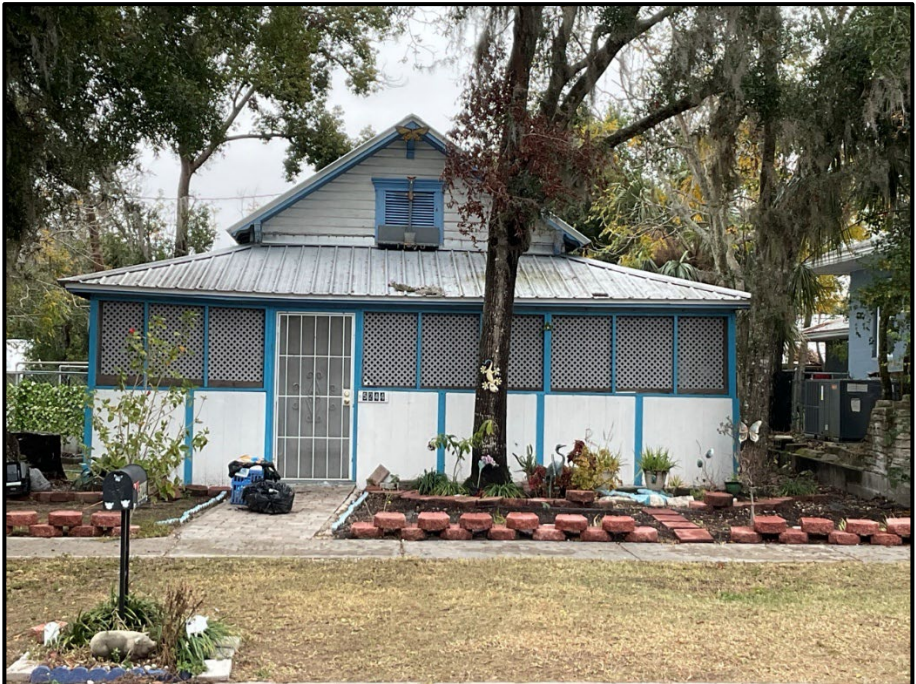
Photograph 18. 5244 9th Street; note enclosed front porch c. 2020 (recommended noncontributing).

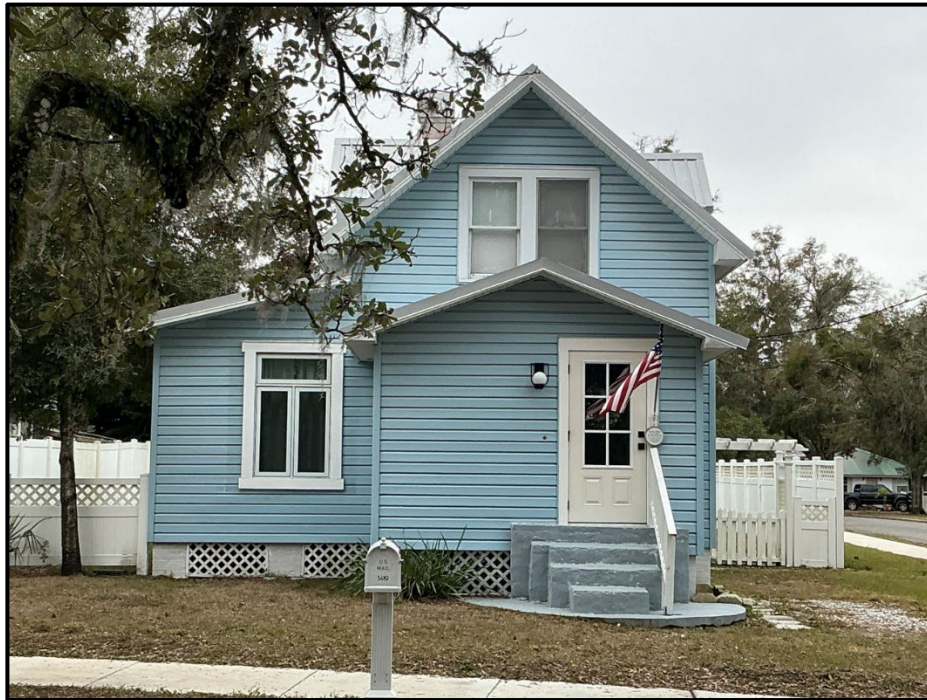
Photograph 19. 5419 9th Street; note vinyl siding, incompatible replacement windows, enclosed front porch, and incompatible front steps (recommended noncontributing).

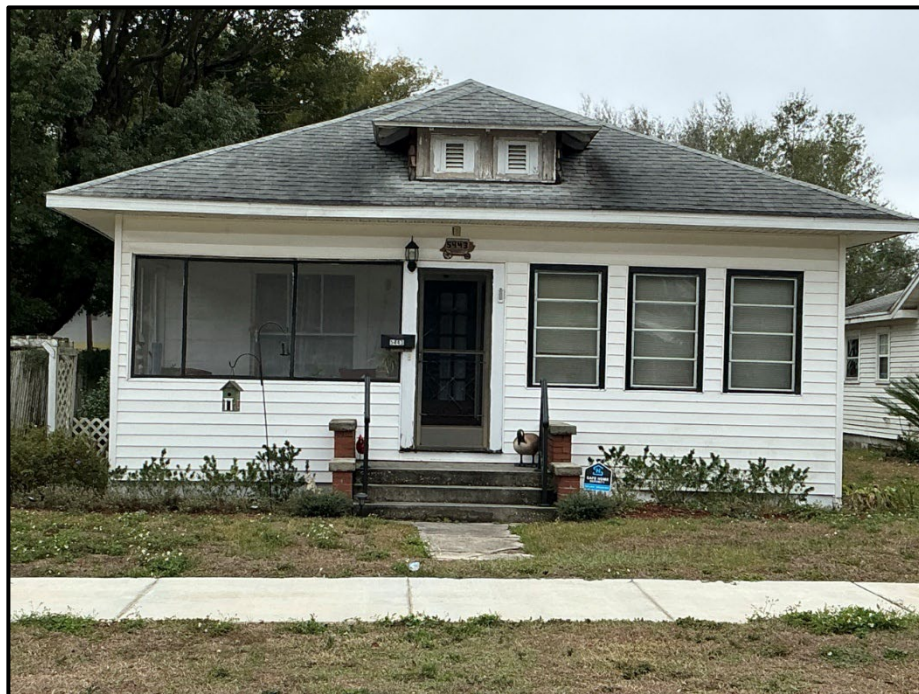
Photograph 20. 5443 9th Street; note vinyl siding, infilled front porch, and replacement windows (recommended noncontributing).

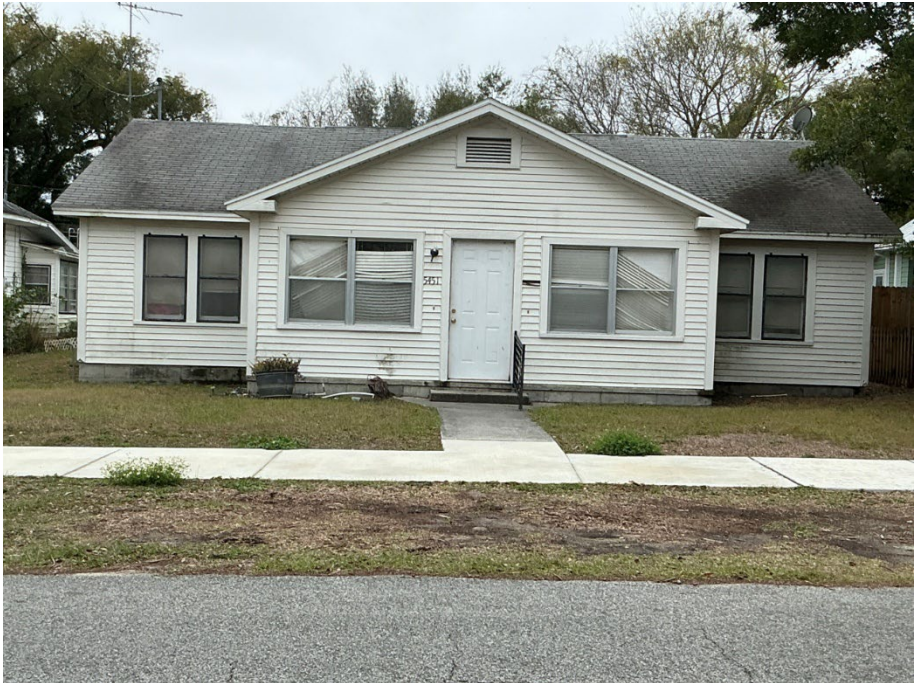
Photograph 21. 5451 9th Street; note vinyl siding and front porch appearing infilled fewer than 50 years ago (recommended noncontributing).

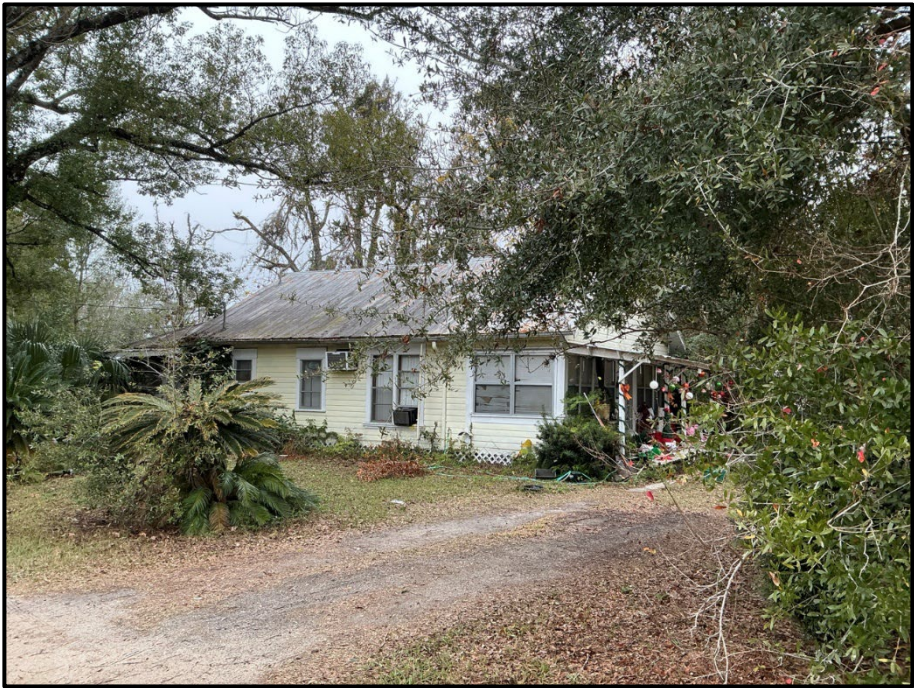
Photograph 22. 5509 9th Street; note front porch enclosed fewer than 50 years ago (new porch added after) and replacement windows not fitting original openings (recommended noncontributing).

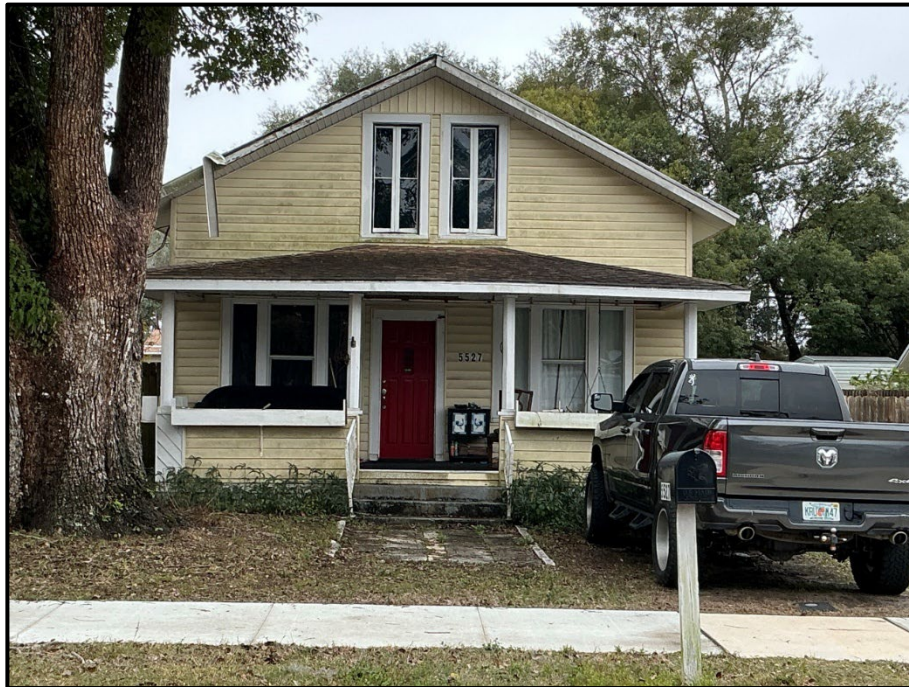
Photograph 23. 5527 9th Street; note vinyl siding and replacement windows (recommended noncontributing).

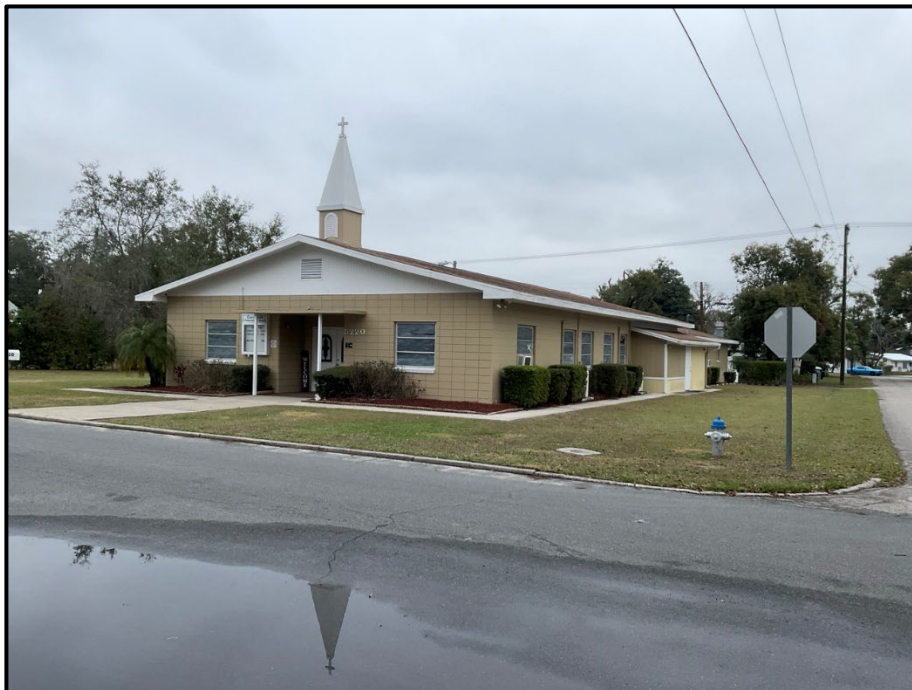
Photograph 24. 5220 10th Street; recommended contributing.

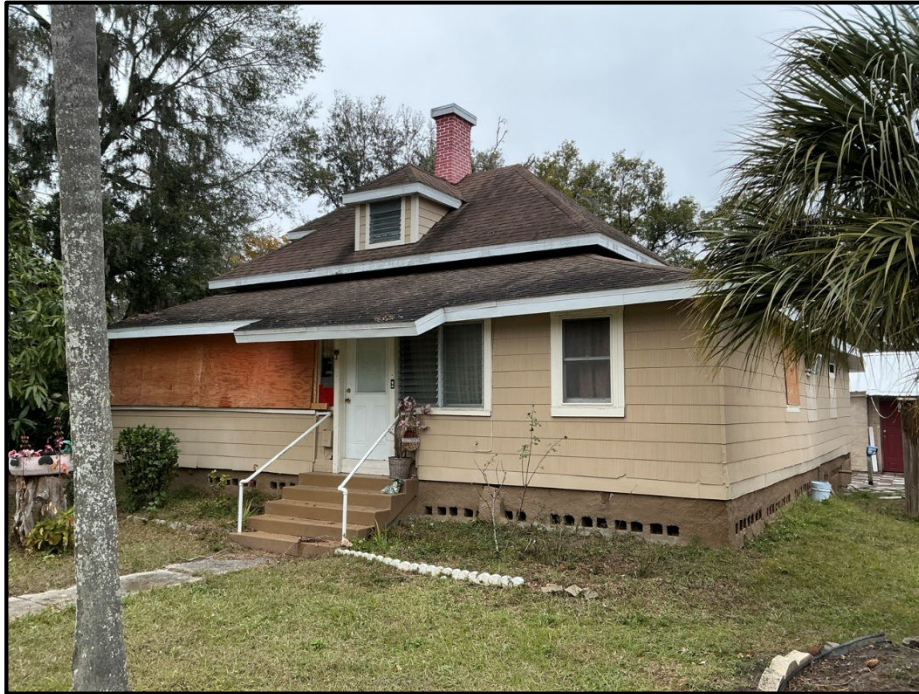
Photograph 25. 5304 10th Street; note enclosed front porch and boarded windows (recommended noncontributing).

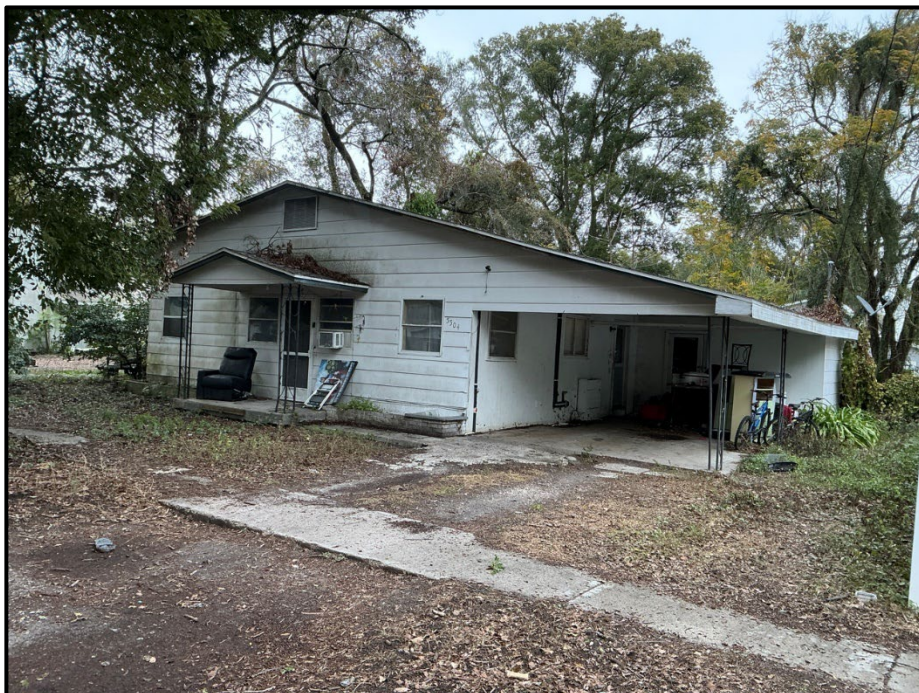
Photograph 26. 5404 10th Street; recommended contributing.

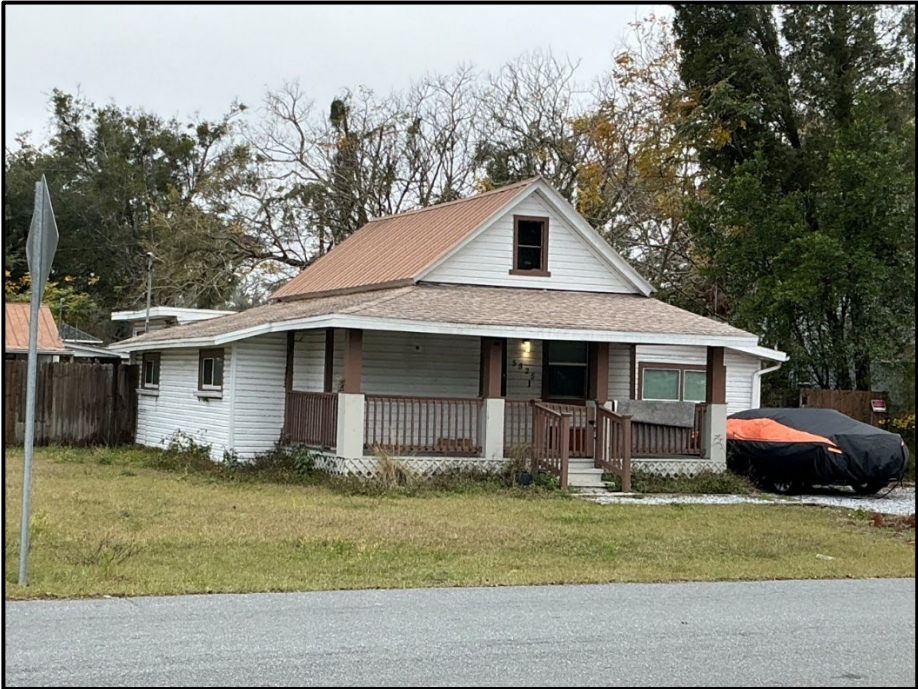
Photograph 27. 5525 10th Street; note enclosed carport, vinyl siding, and replacement windows (recommended noncontributing).

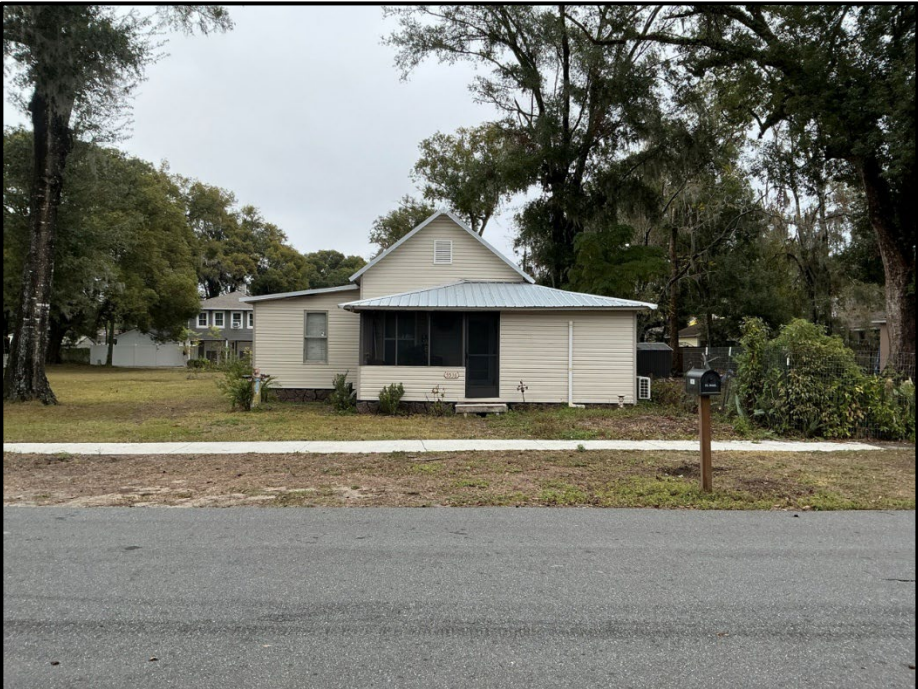
Photograph 28. 5536 10th Street; note vinyl siding, replacement windows, and enclosed porch (recommended noncontributing).

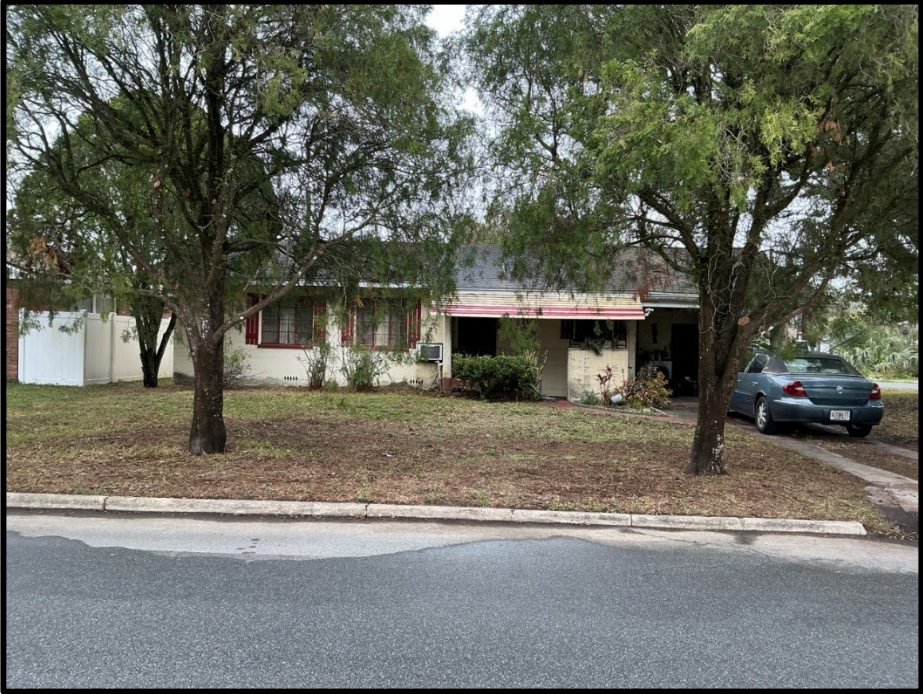
Photograph 29. 5426 11th Street; recommended contributing.

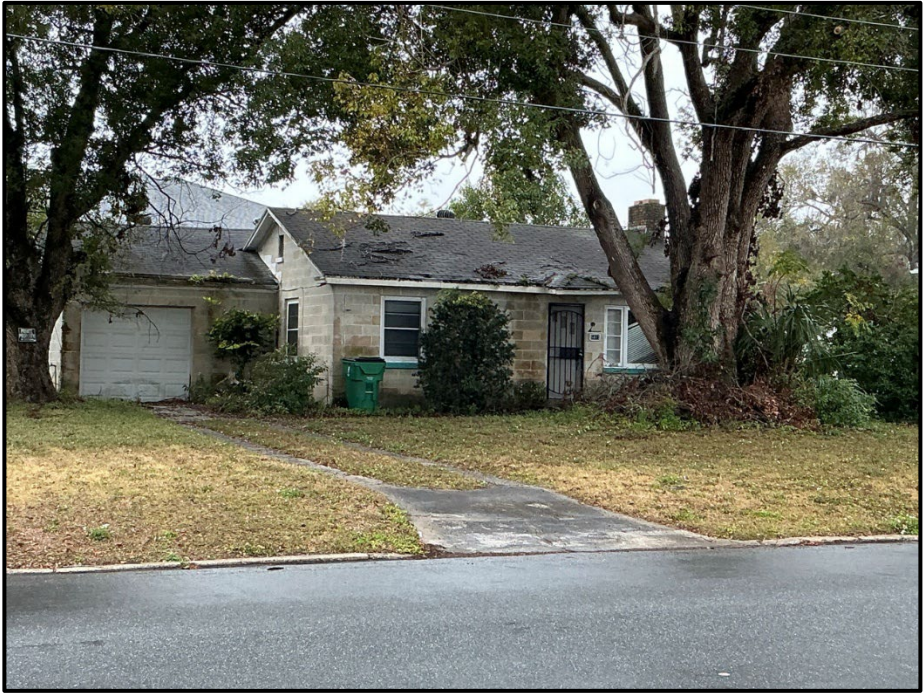
Photograph 30. 5413 11th Street; recommended contributing.

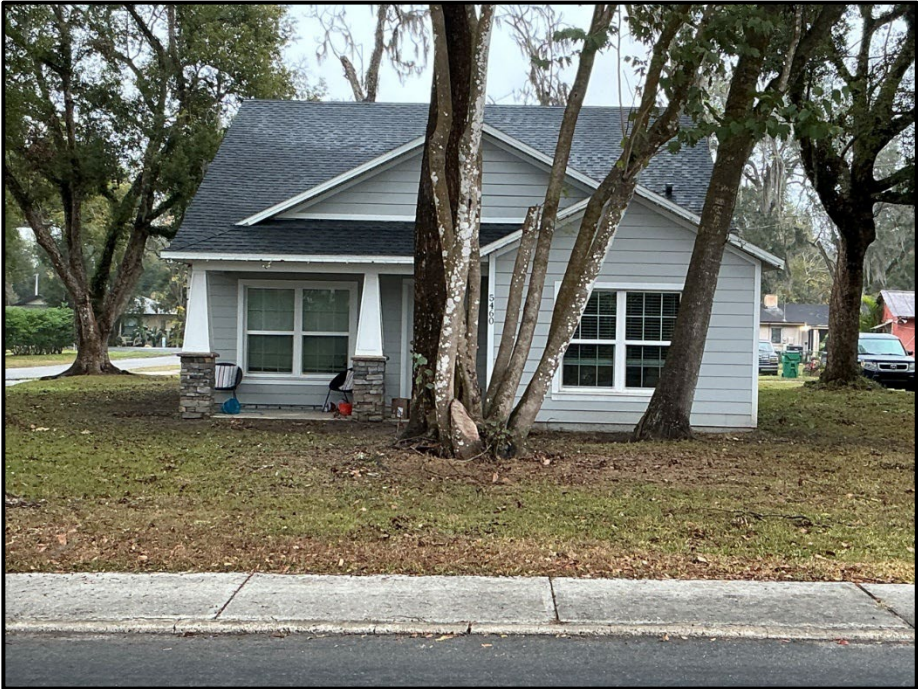
Photograph 31. 5460 11th Street; new construction (recommended noncontributing).

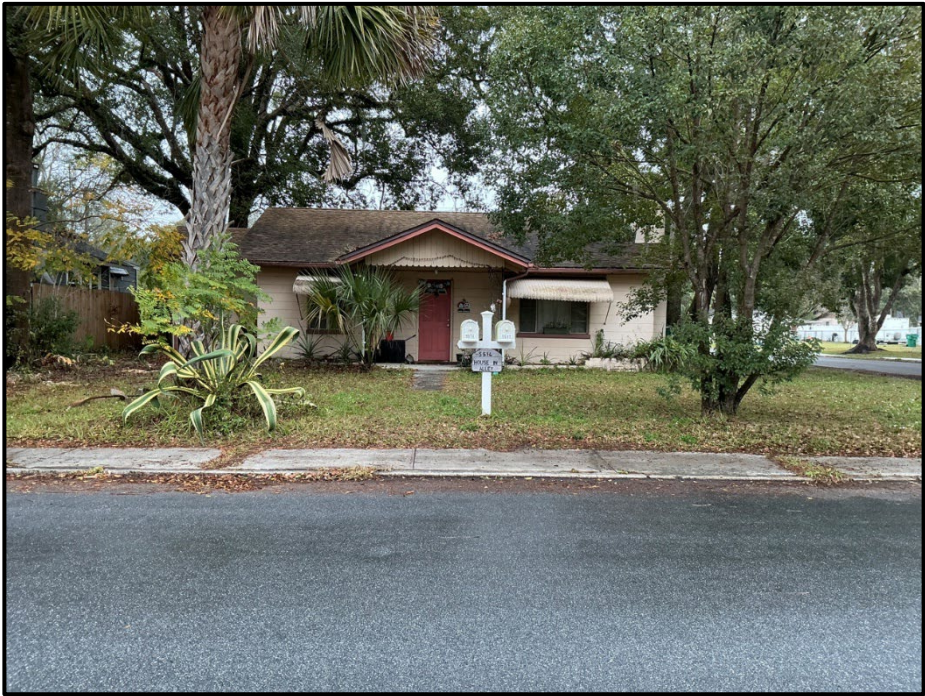
Photograph 32. 5512 11th Street; recommended contributing.

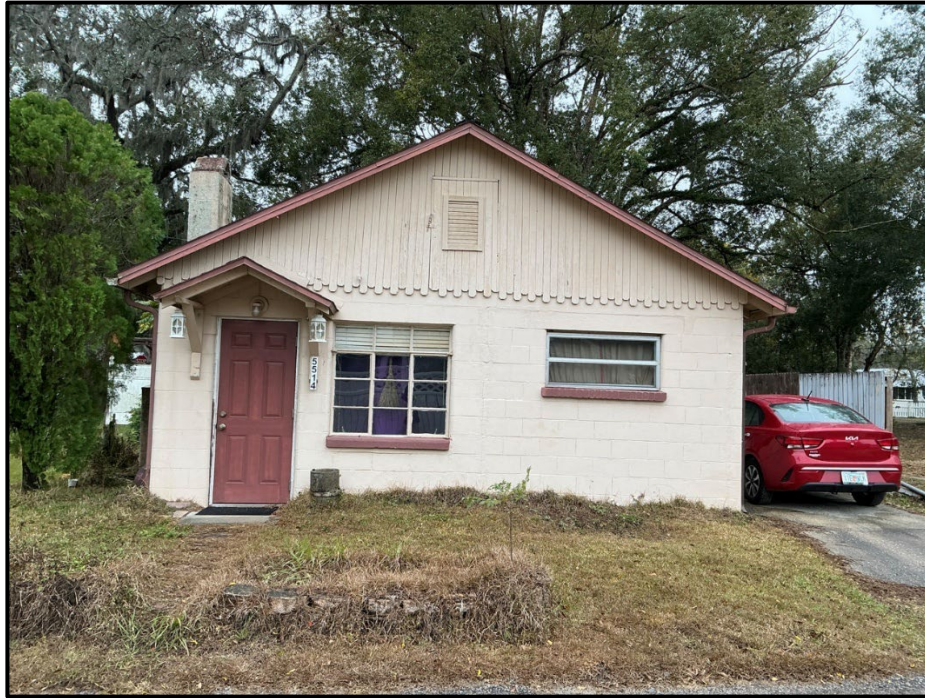
Photograph 33. 5514 11th Street; recommended contributing.

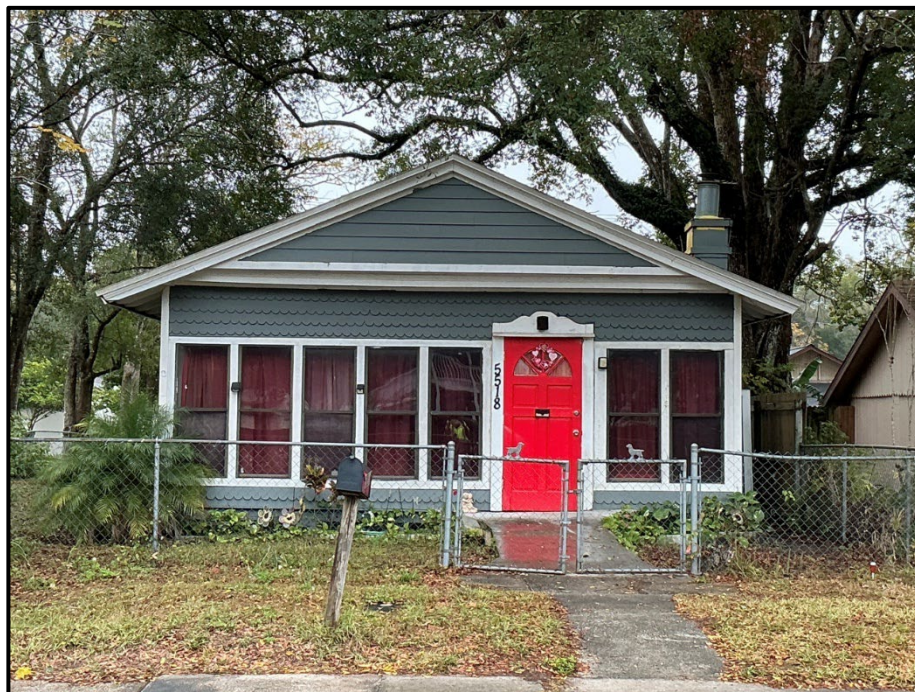
Photograph 34. 5518 11th Street; note enclosed front porch with anachronistic fish scale trim (recommended noncontributing).

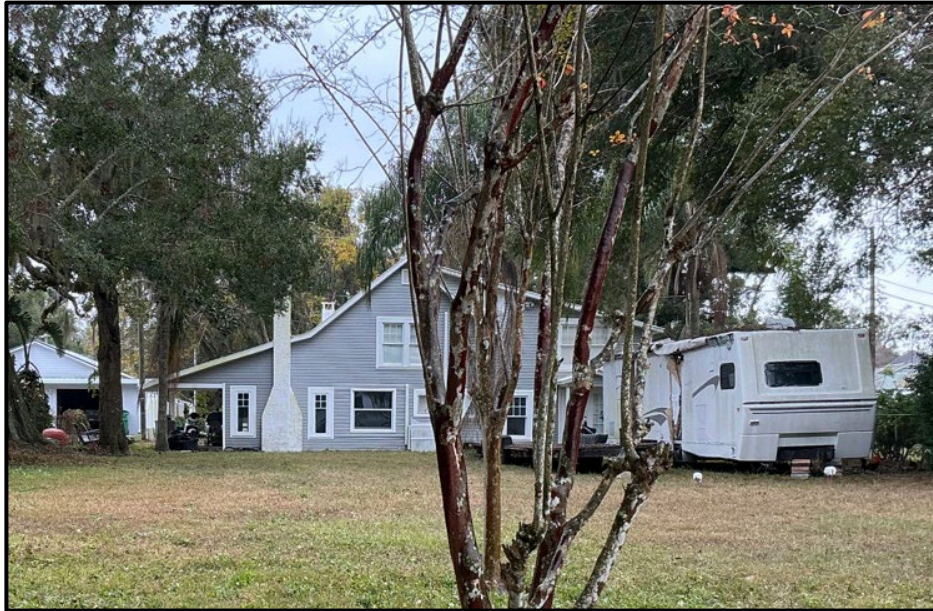
Photograph 35. 5519 11th Street; note vinyl siding and replacement windows (recommended noncontributing).

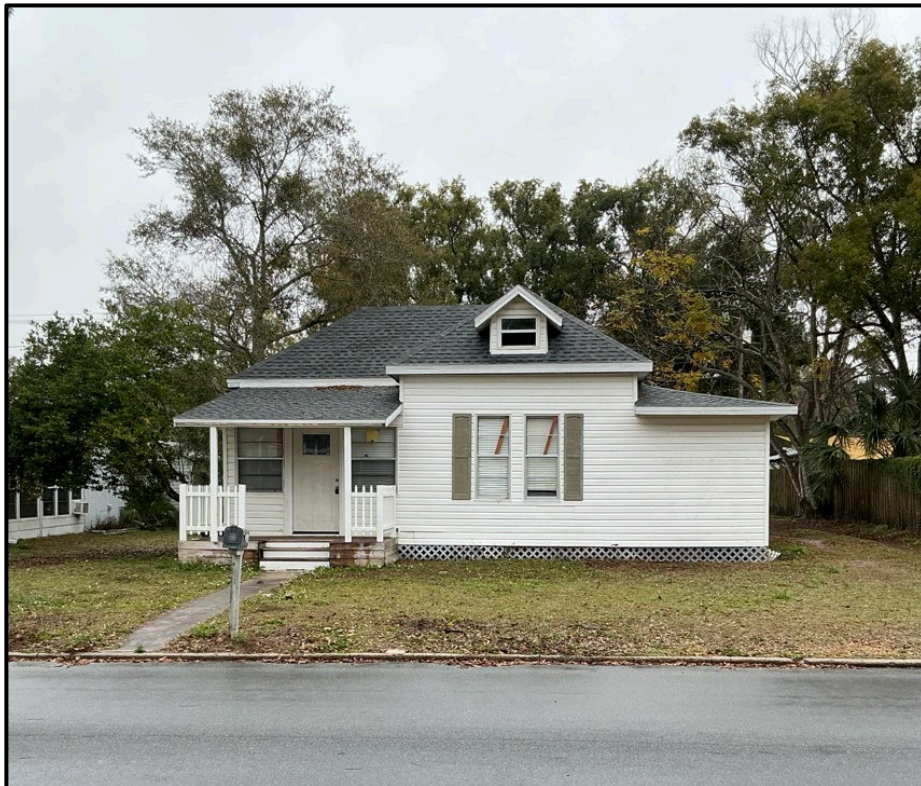
Photograph 36. 5548 11th Street; note vinyl siding, replacement windows and front door, and enclosed porch (recommended noncontributing).

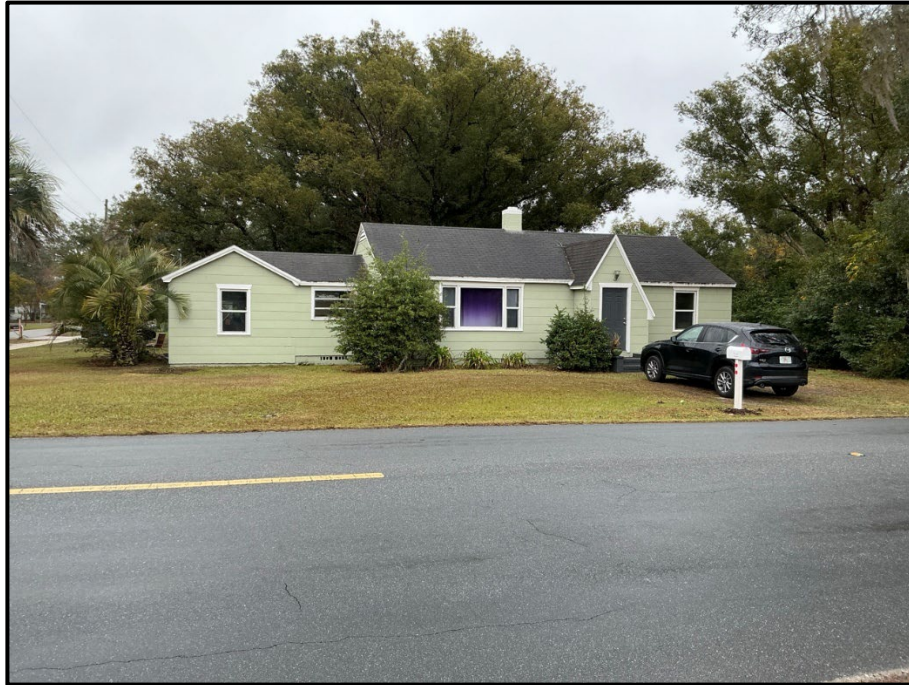
Photograph 37. 5546 12th Street; recommended contributing.
