**HISTORIC PRESERVATION
ZEPHYRHILLS, FLORIDA**

**Thursday, October 30, 2025
6:00 PM**

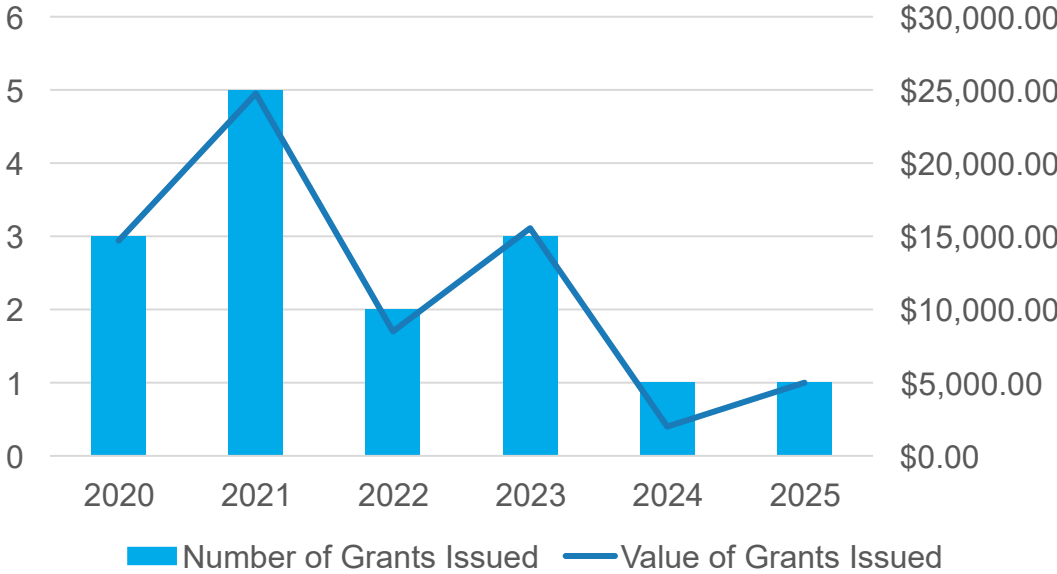
Ad Valorem Tax Exemption

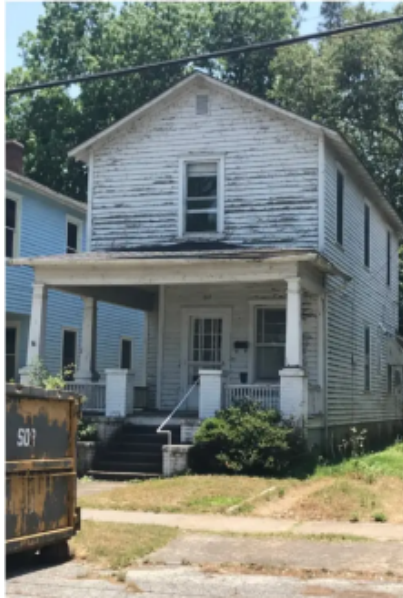
“I can make more money if I demolish this old building and redevelop this site.”

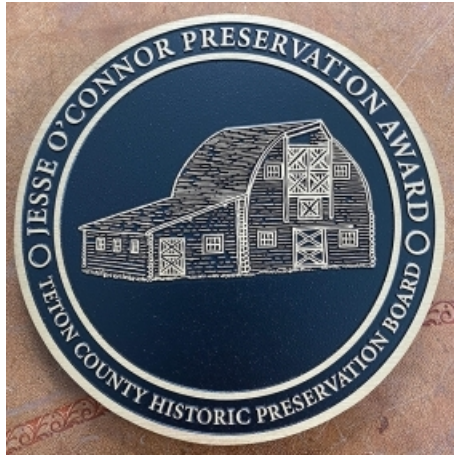
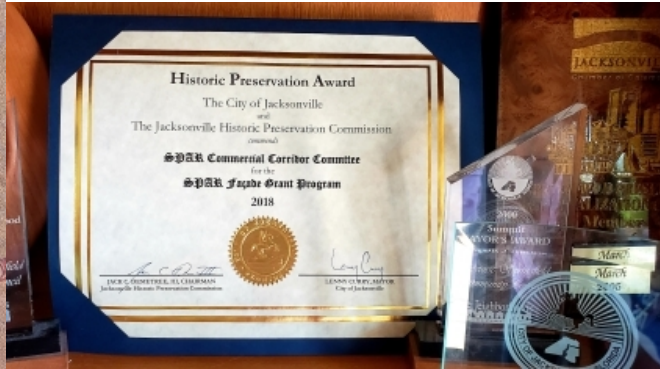
With the recommendation of the Board staff can explore ways to implement an award program.
